DURABILITY TEST OF TRUCK,

UTILITY, 1/4-TON, 4 BY 4, M151

DEVELOPMENT AND PROOF SERVICES

First Report

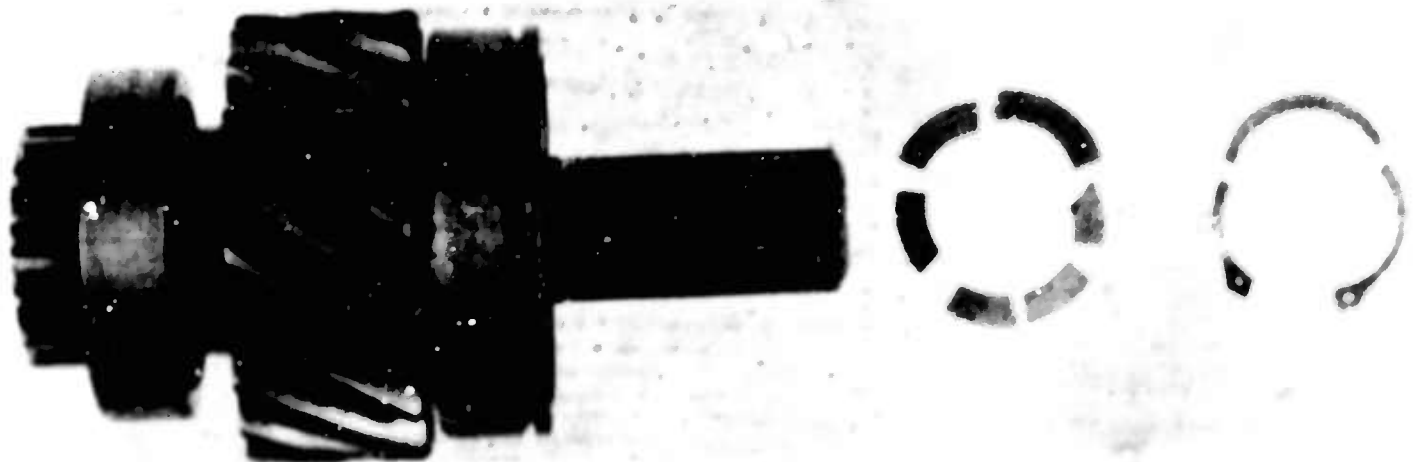
Odometer 7967 - The transfer case was fractured as a result of a broken spacer on the rear output shaft and/or maladjustment of the front wheel drive control. Figures 5 through 7 show condition of transfer case components after failure. Failed and damaged parts were replaced.

Figure 5 - B23943: Broken Spacer and Snap Ring Located at Rear of Rear Output Shaft.

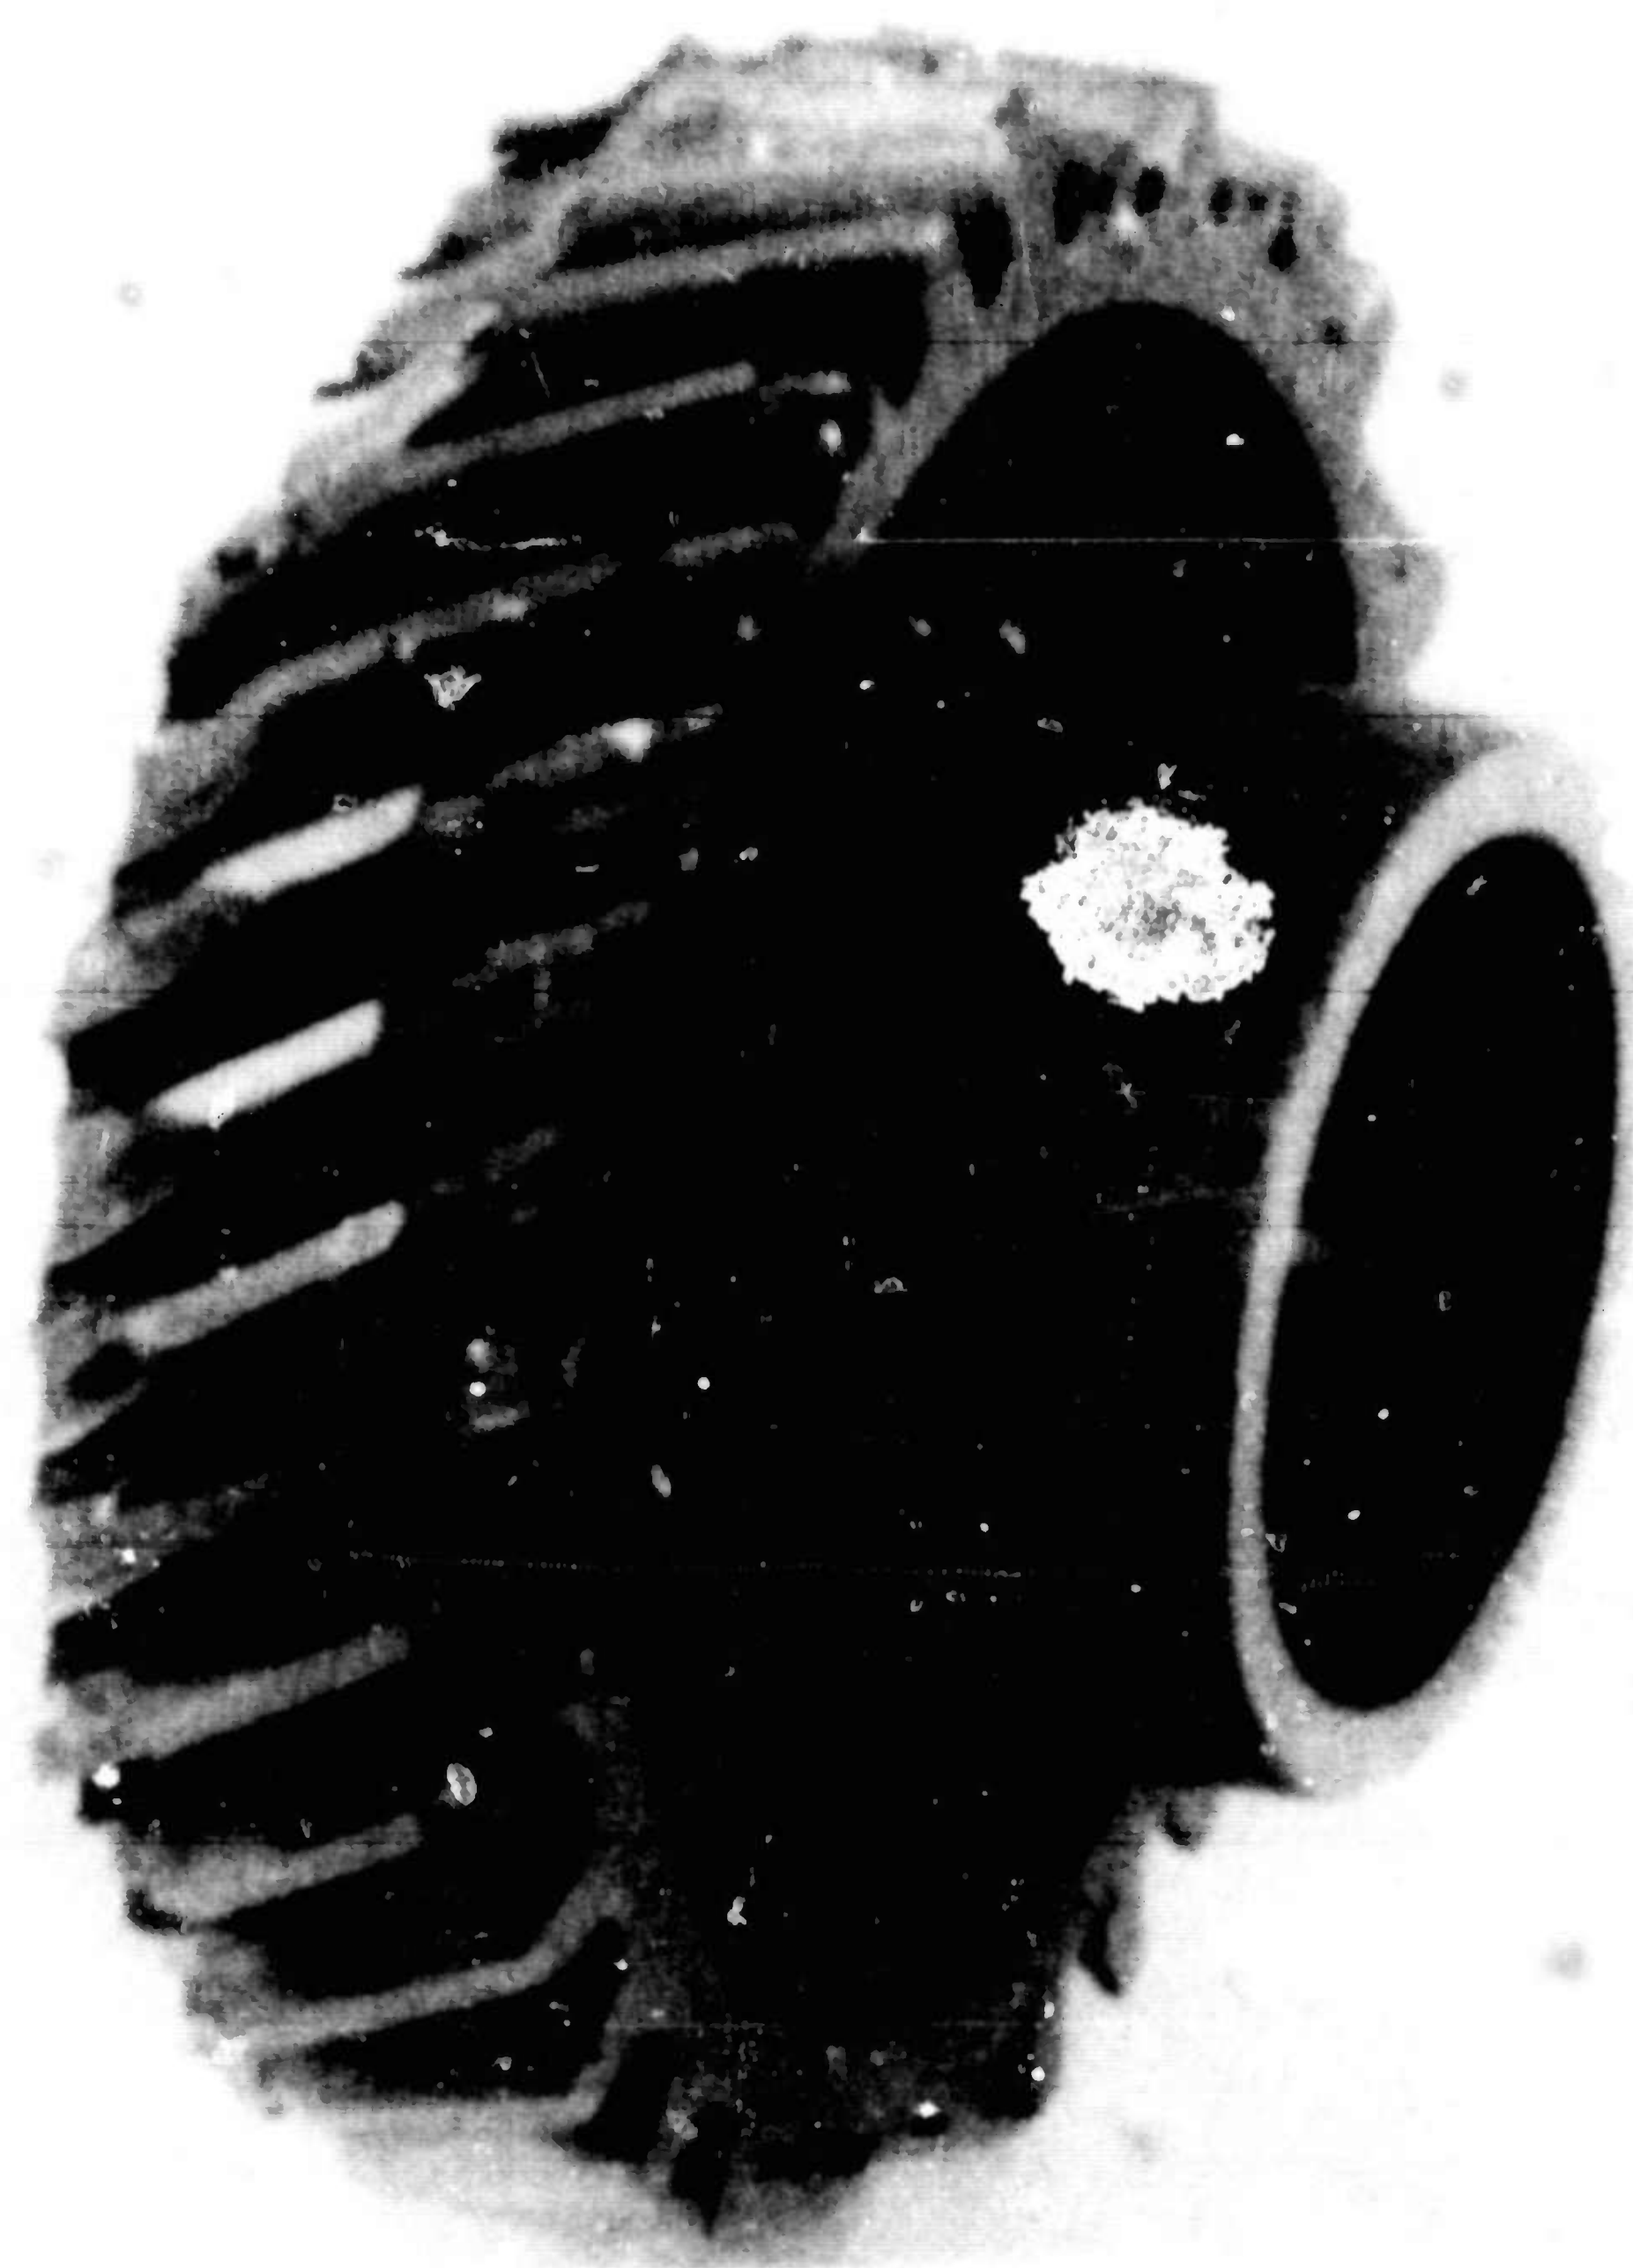
Figure 6 - B23942: Condition of Transfer Case Intermediate Gear

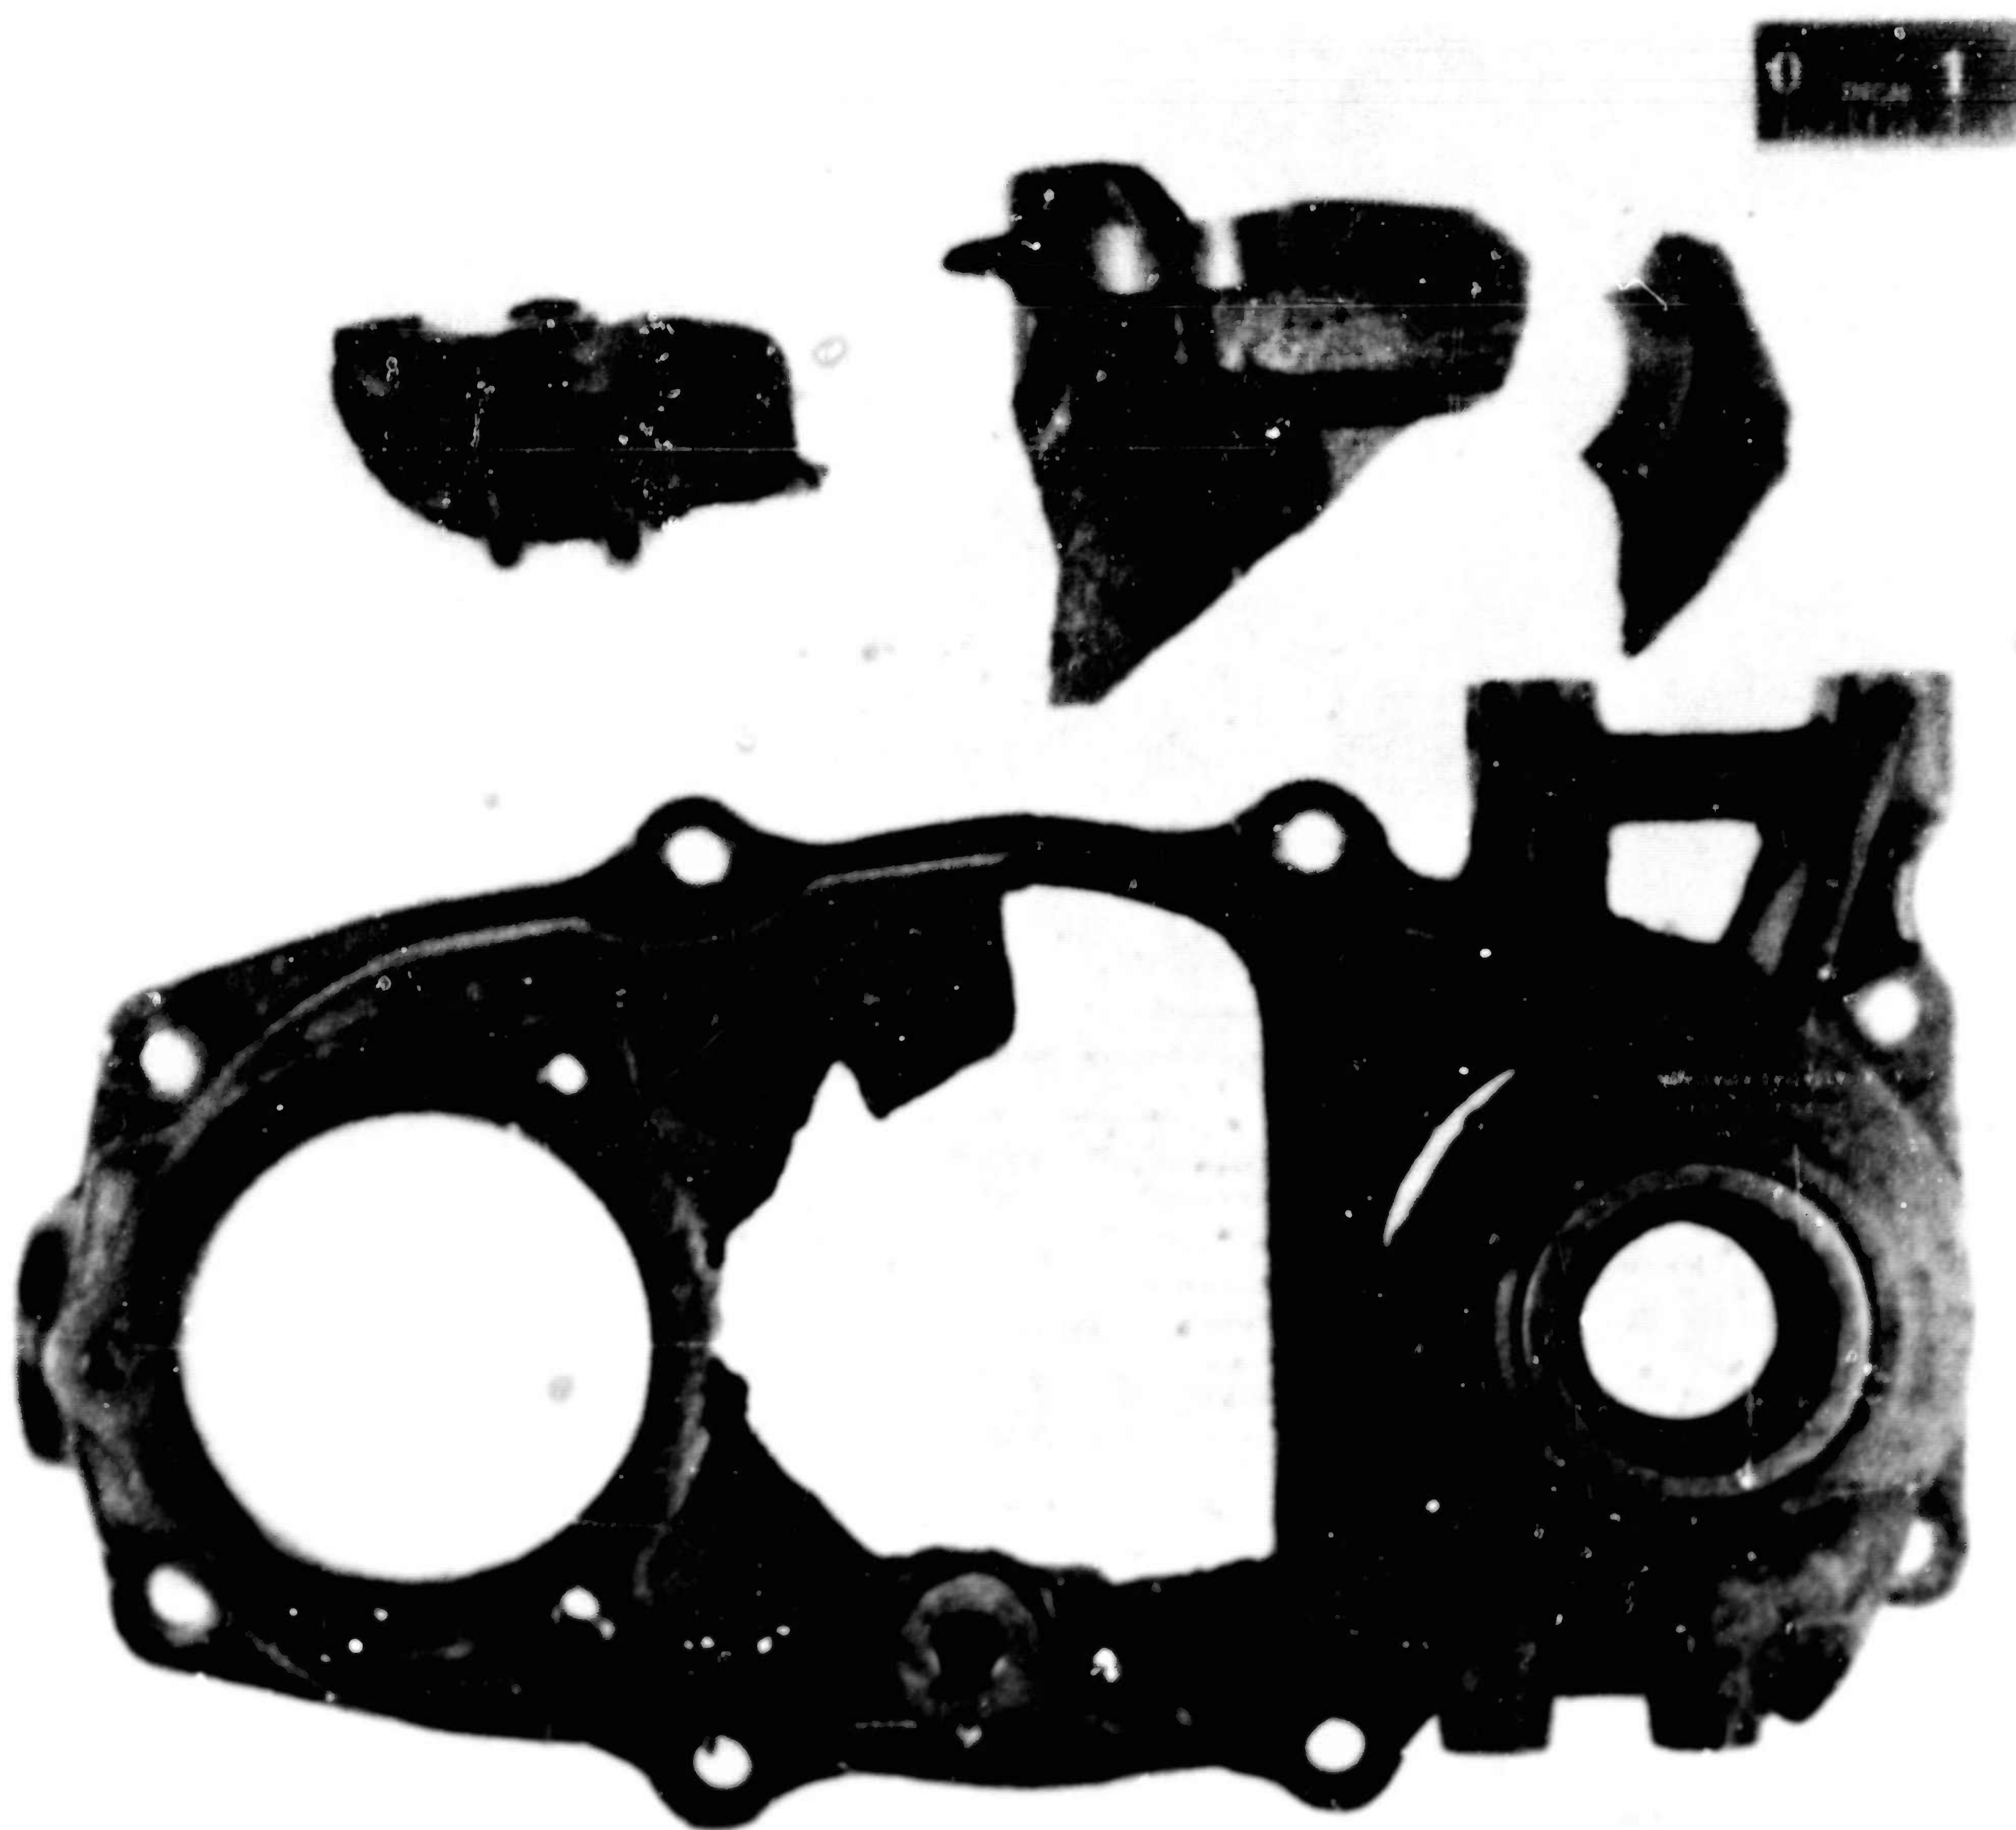
Figure 7 - B23944: Fractured Transfer Case

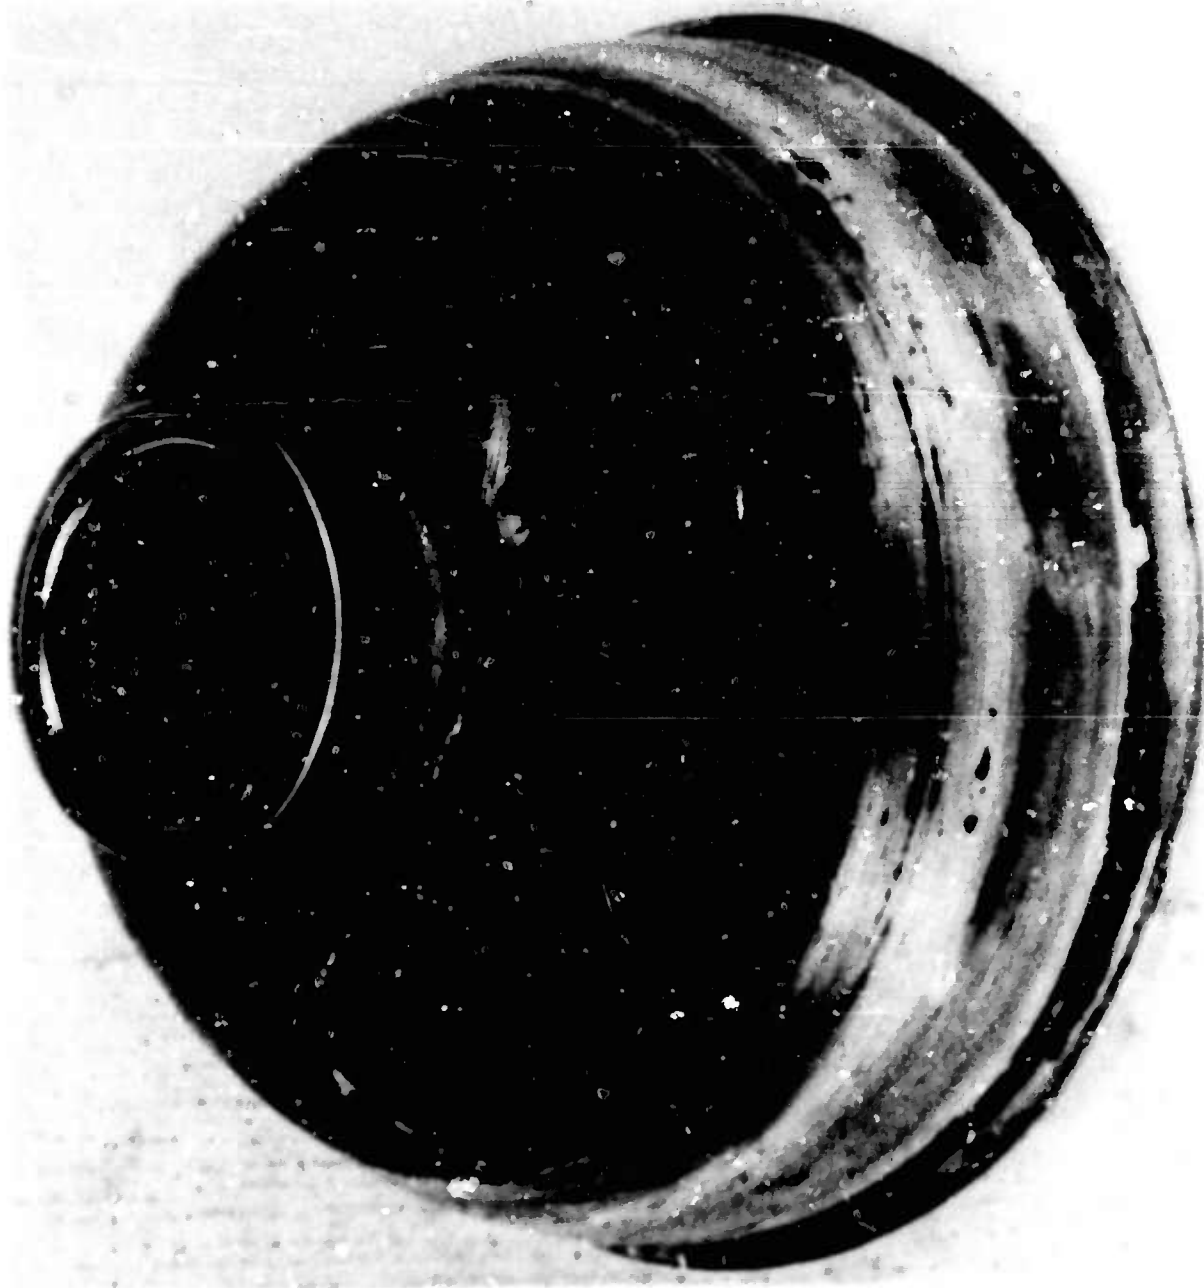
Odometer 7543 - Inspection of the front constant velocity joint seals and seal seats disclosed that the seals were forced into the seats to the extent that the rear portions of the seats were bent, causing the seals to fuse to the seats. The inner surfaces of the seals were badly damaged. Figures 8 and 9 show damaged seal seat and seal.

Figure 8 - Deformed Seal Seat in Constant Velocity Joint.

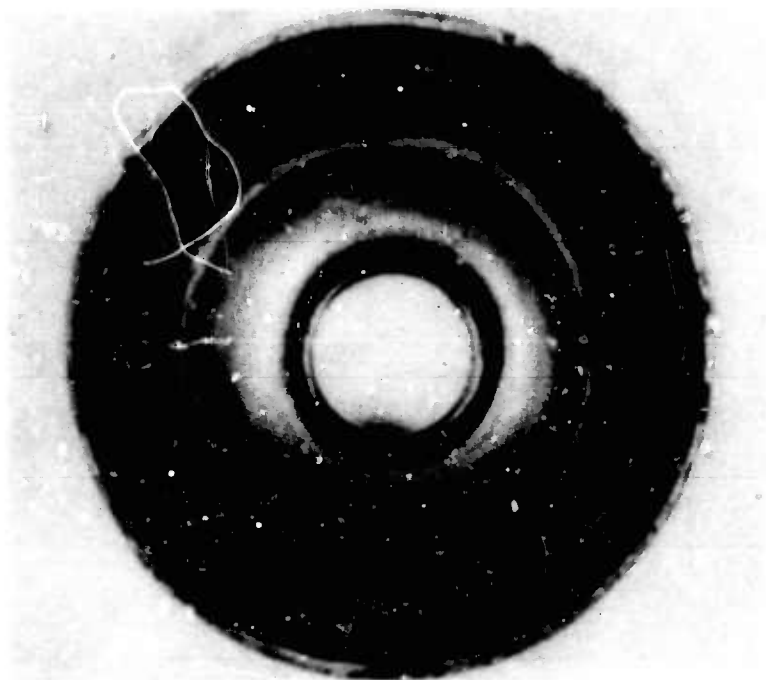
Figure 9 - Condition of Constant Velocity Joint Inner Surfaces. Note that Seal is Fuzed to Seal Seat.

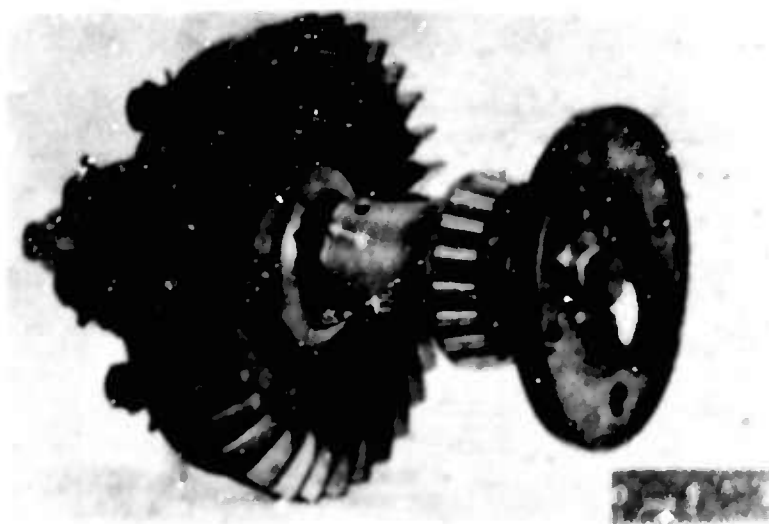
Odometer 7967 - The rear differential case was fractured on the right side between the ring gear and support bearing. This failure could have occurred earlier, resulting in the differential becoming noisy at odometer 6420 (see above). Figure 10 shows fractured case.

Figure 10 - 124689: Fractured Rear Differential Case.

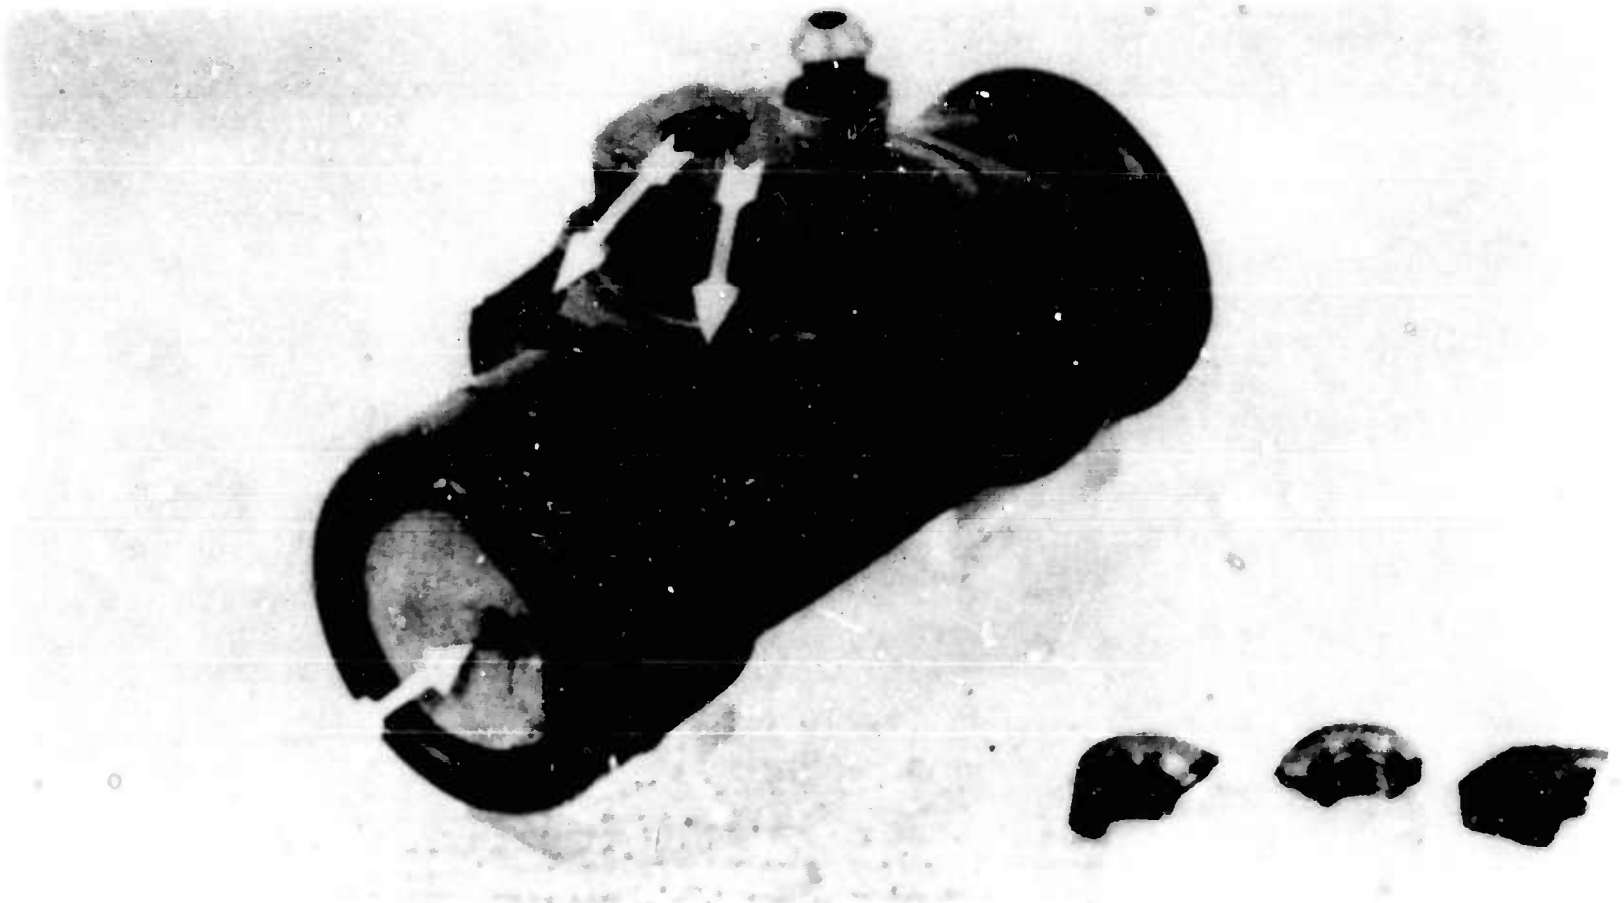
Odometer 826 - During service brake tests at 30 mph, the right front brake cylinder failed in the area around the two rear cap screws which hold it to the backing plate. The backing plate and the rib section of the rear shoe were bent; the rear piston was deeply scored as a result of this failure. Figure 11 shows failed brake cylinder.

Figure 11 - B23391: Failed Right Front Brake Cylinder

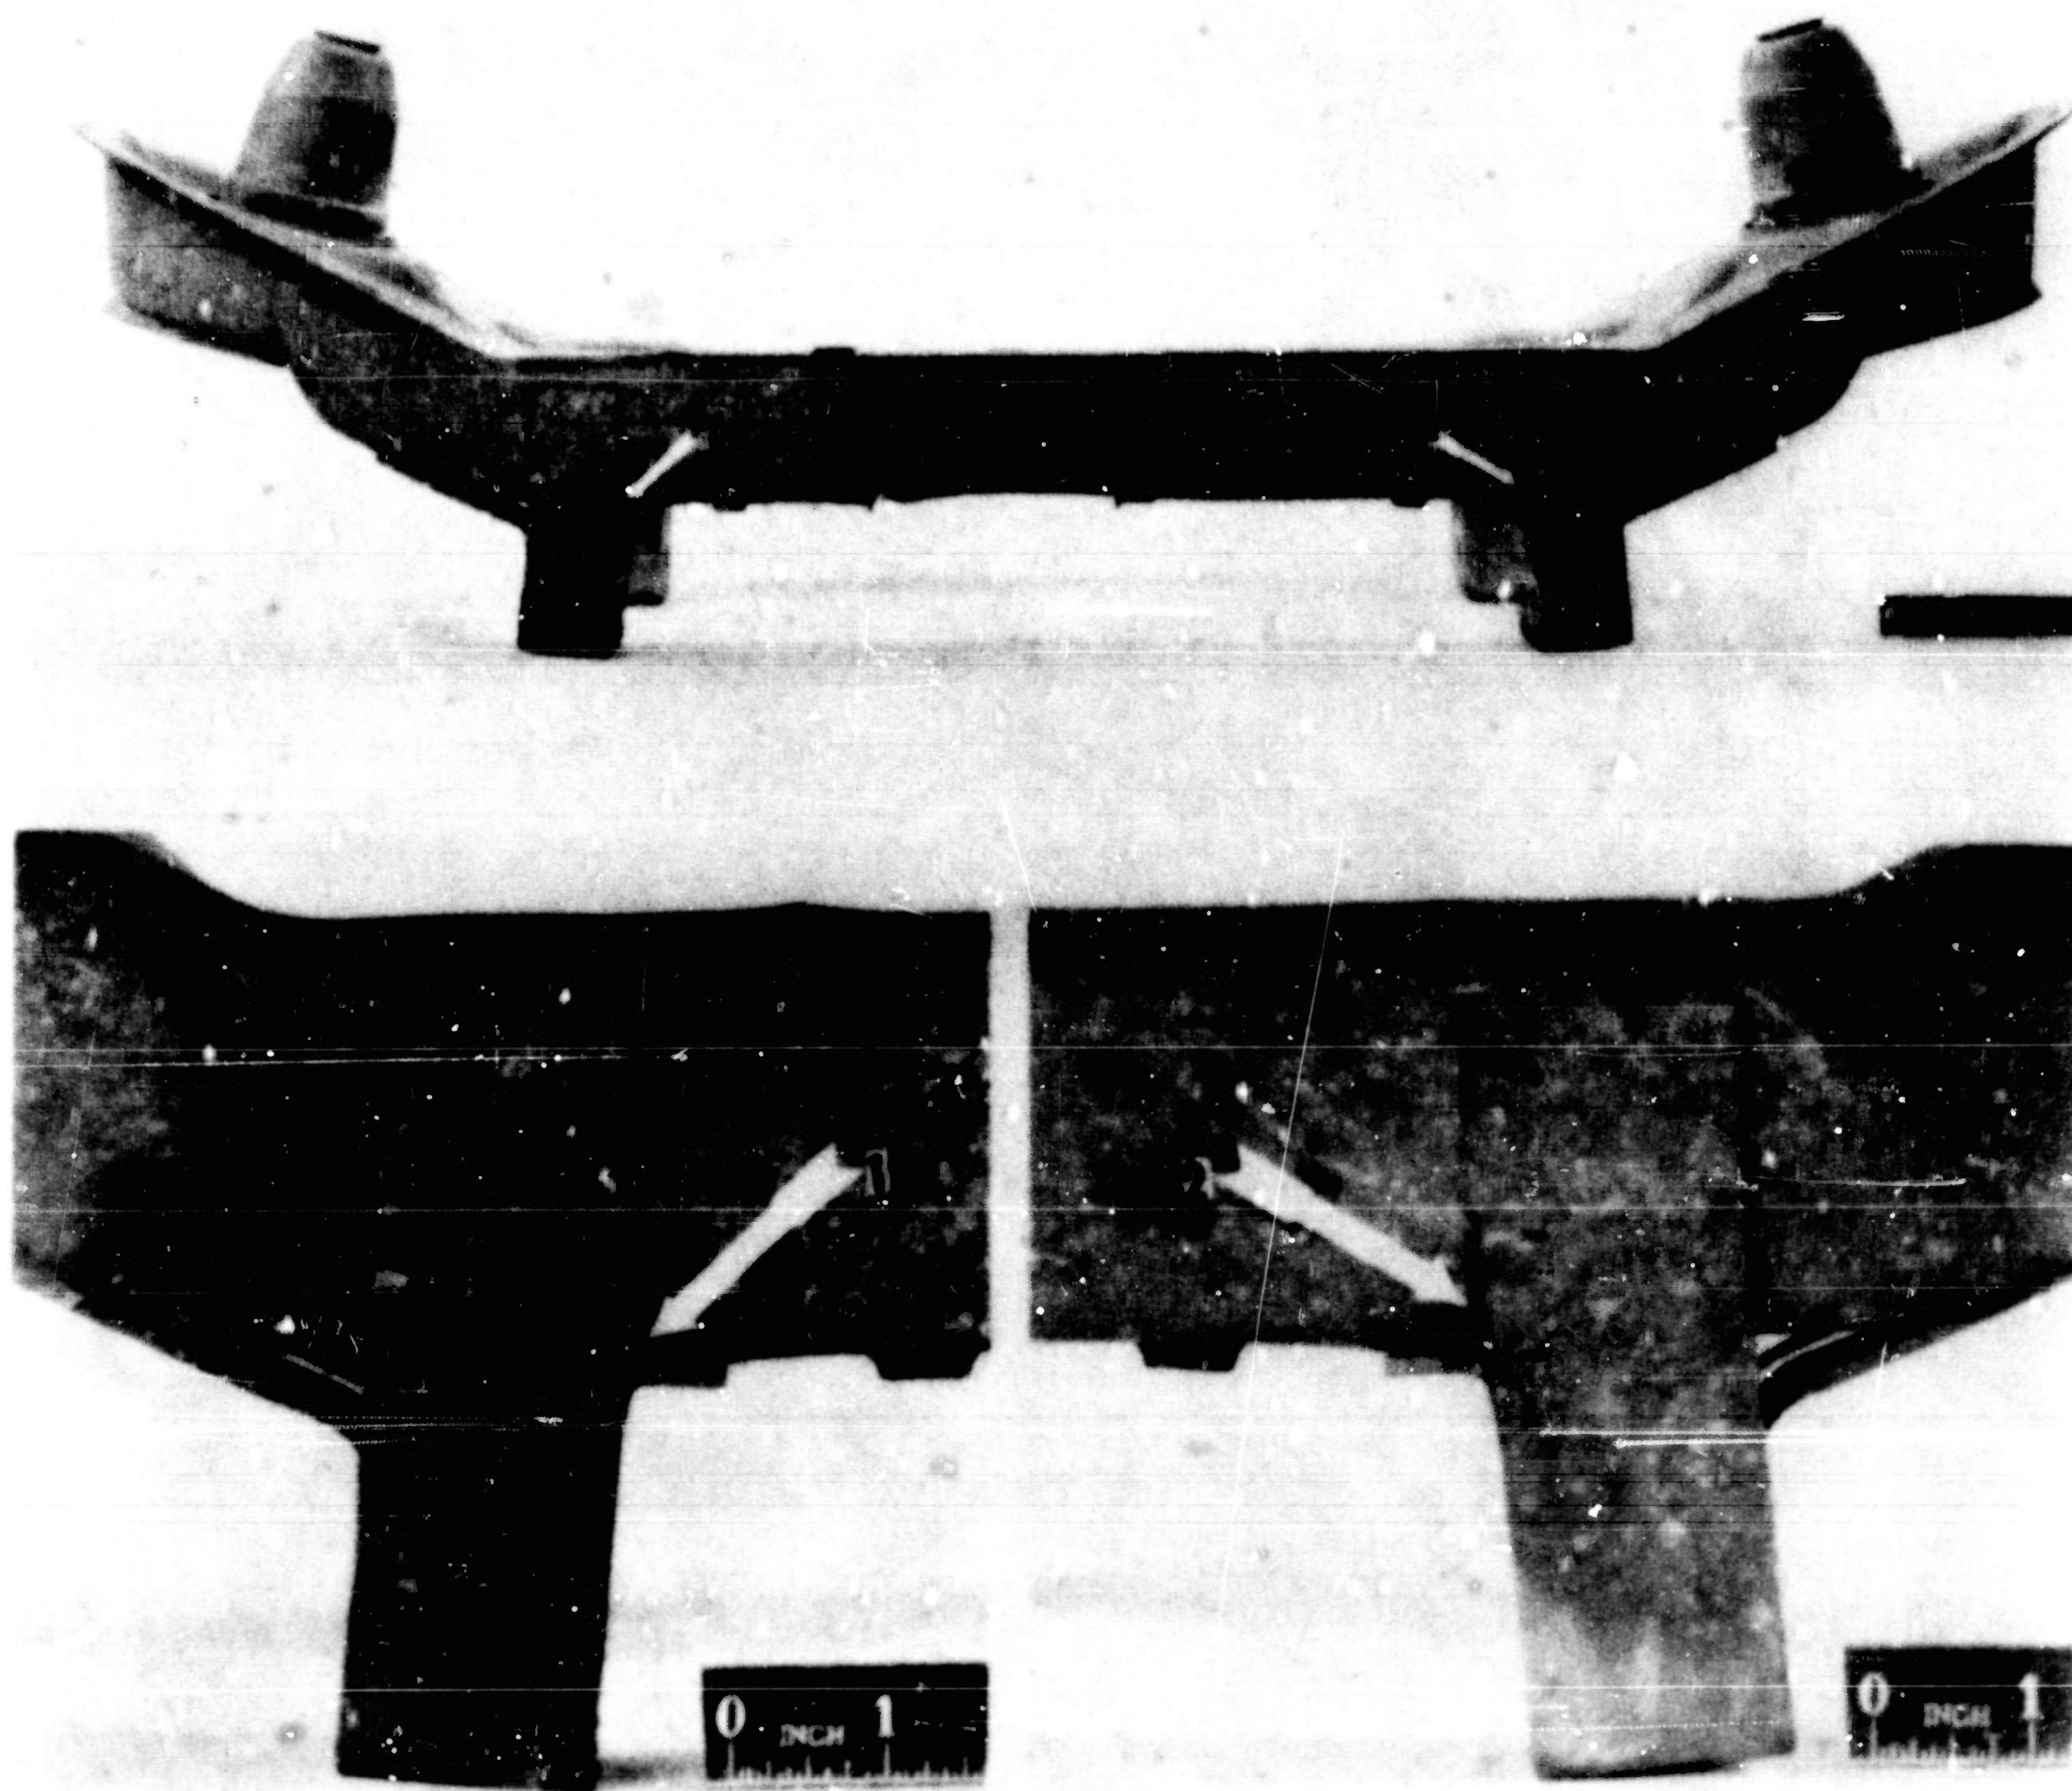
Odometer 826 - The vertical support brackets of the front cross-member began to bend. Figure 13 shows distortion of these brackets. This cross-member was replaced with one of stronger design.

Figure 13 - B23602: Distorted Front Cross-Member

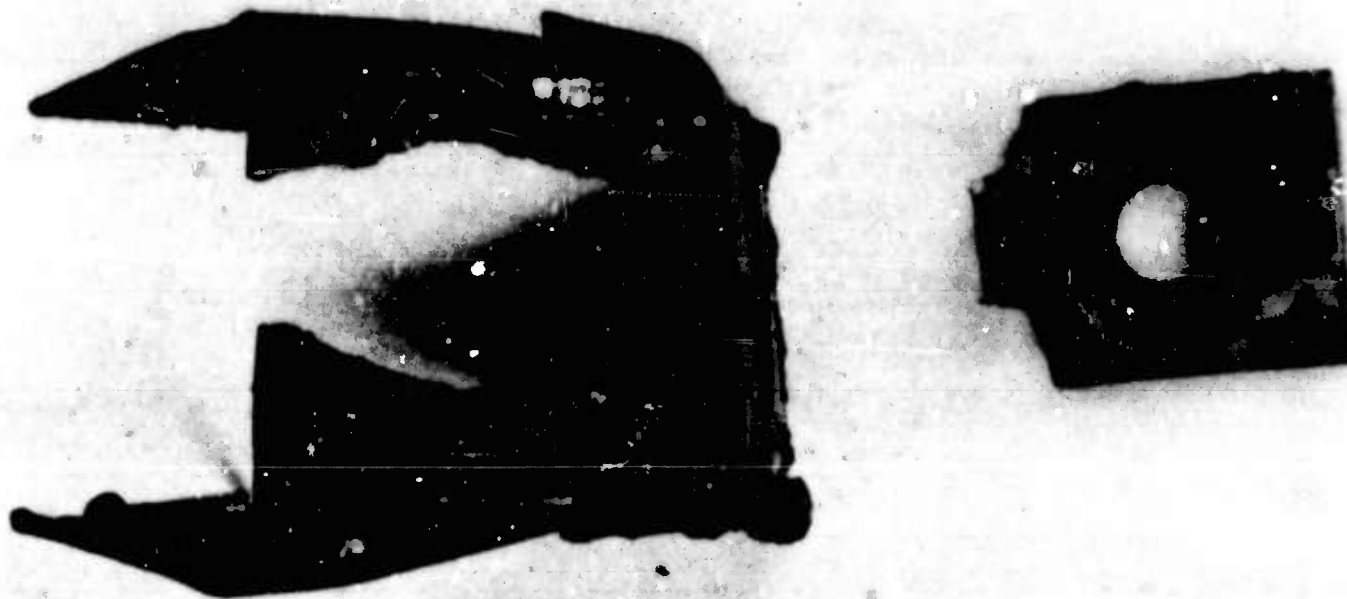
Odometer 6451 - The horizontal portion of the rear differential front mounting bracket failed, allowing the front end of the differential to drop down and resulting in the pulling of the rear propeller shaft out of the transfer case. Upon investigation it was disclosed that the horizontal portions of the two rear mounting brackets had been flexing and had developed cracks.

Figure 15 - Failed Rear Differential Front Mounting Bracket.

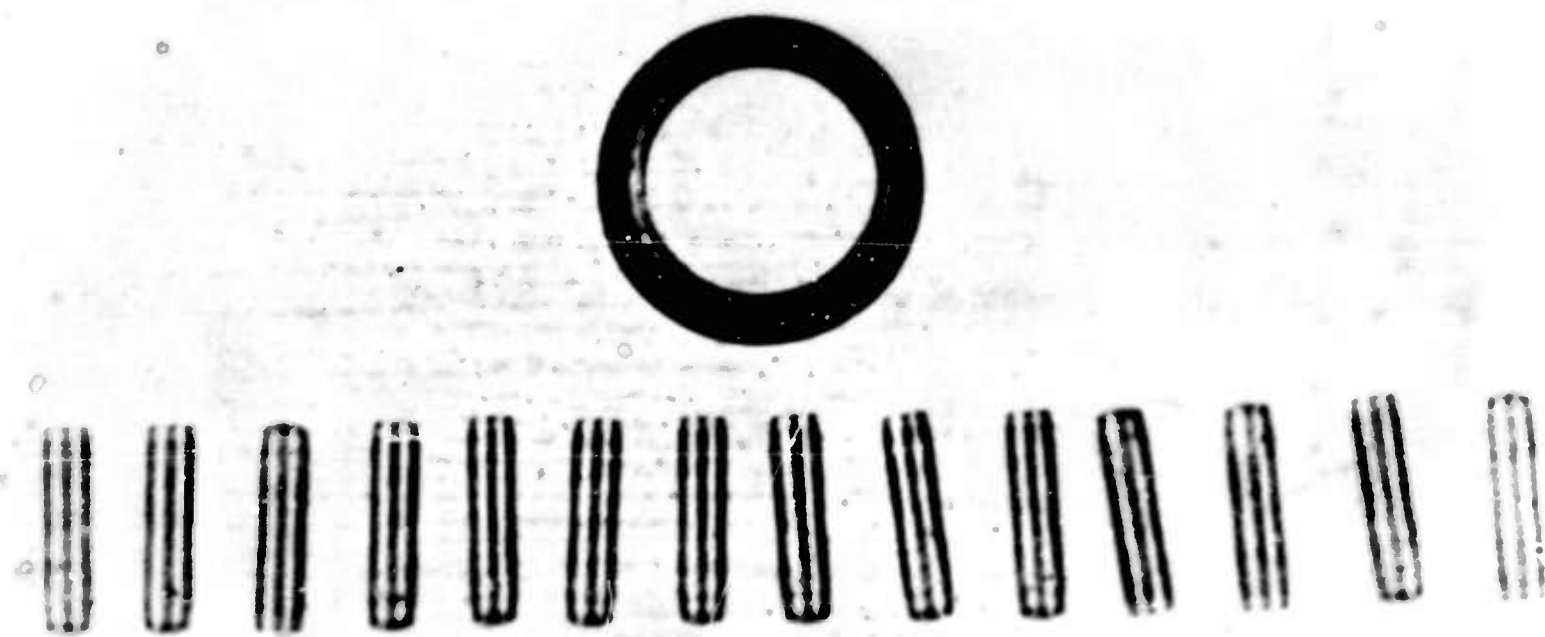
Figure 18 - B26007 (top): Thrust Washer and Needle Bearings from the Front of Transmission Output Shaft. Note Tapered Wear.

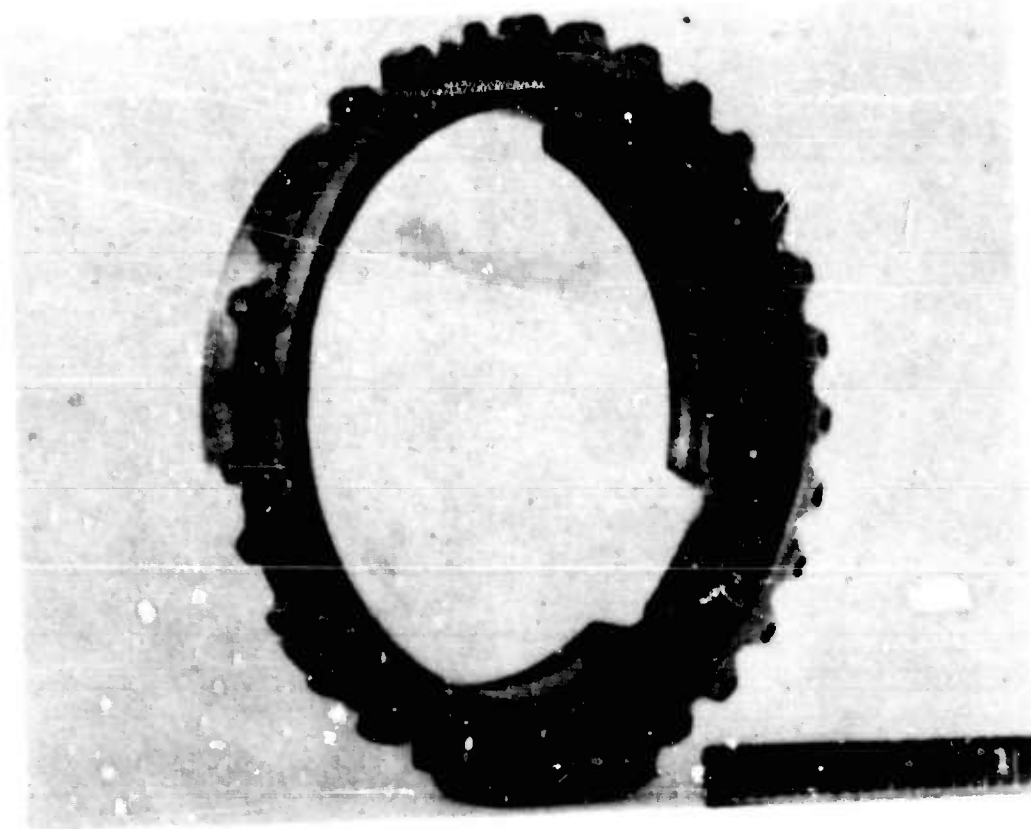
Figure 22 - B26005: Third and Fourth Gear Synchronizer Clutch. Note Irregular Wear on Inner Surface.

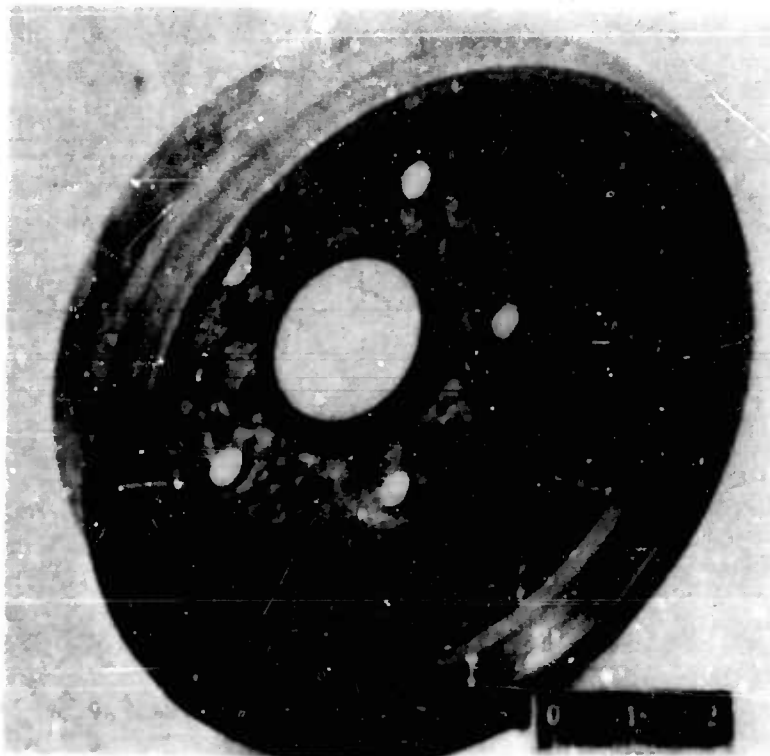
Figure 29 - B26001:
Scored Right Front Brake Drum.

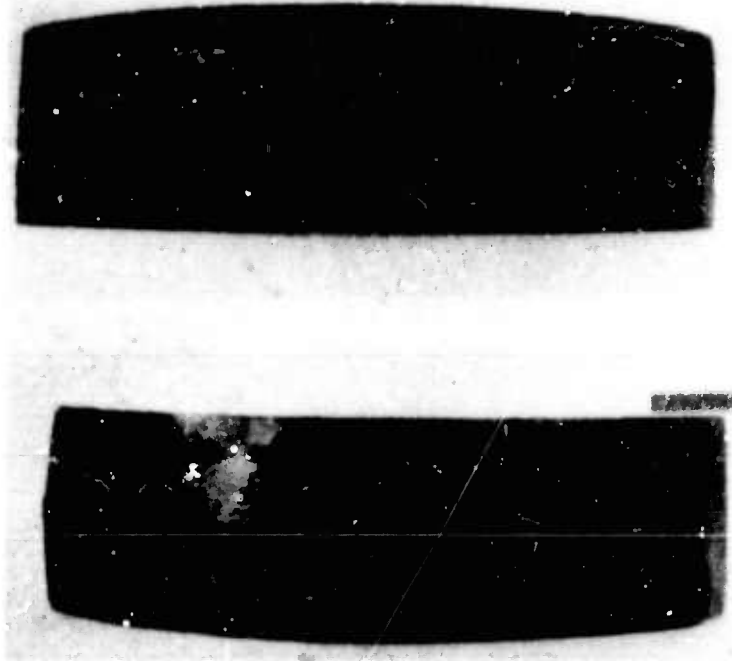
Figure 30 - B26904 (Bottom): Condition of Secondary Brake Lining.

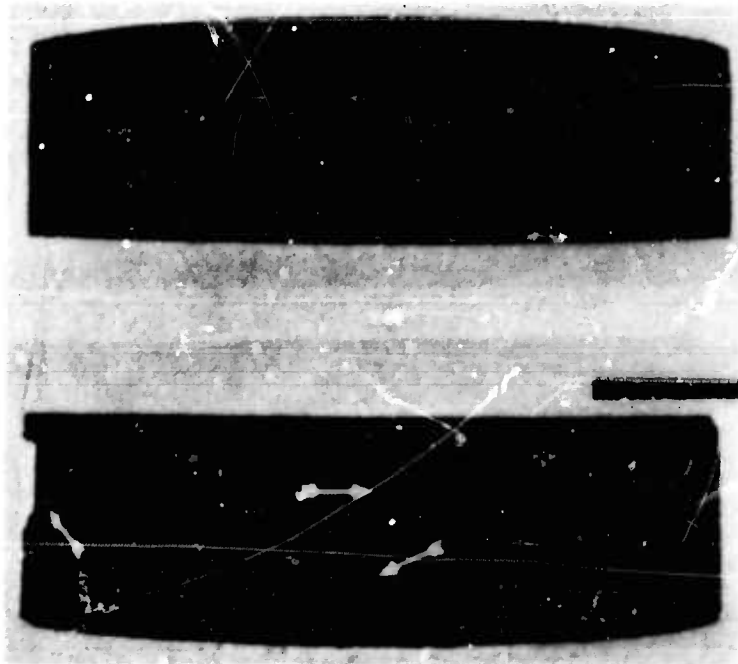
Figure 31 - B26906 (Bottom): Left Front Secondary Brake Lining.

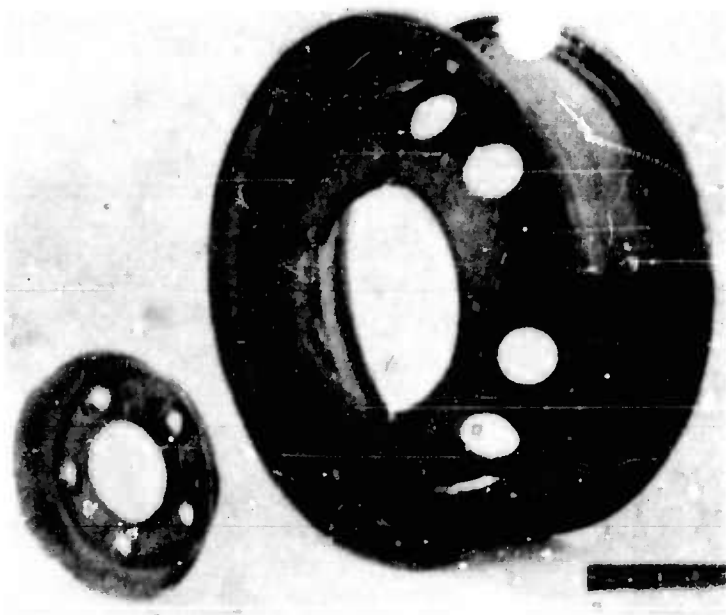
Odometer 795 - While negotiating a right turn the left rear wheel broke in the disked section, thus leaving only the center section of the wheel on the hub (Fig. 32). At odometer 854 the right rear wheel broke in a similar manner while negotiating a left turn (Fig. 33).

Figure 32 - B25900:
Broken Left Rear (Steel) Wheel.

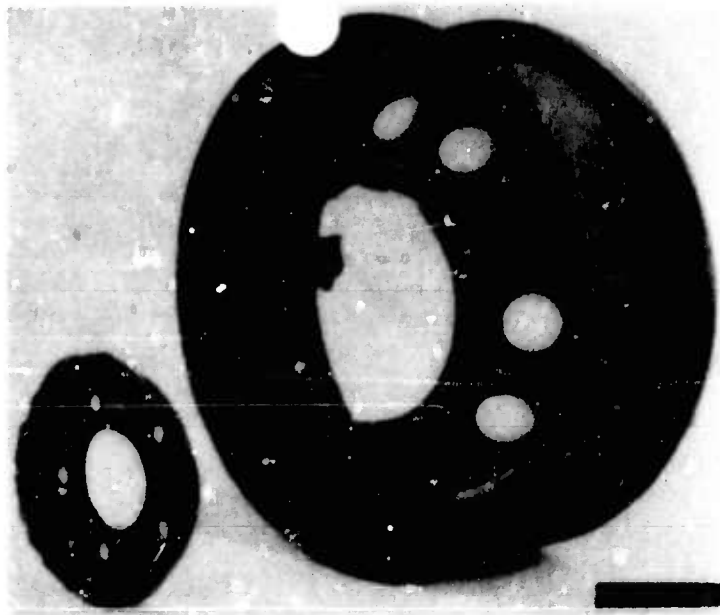
Figure 33 - B25901:
Broken Right Rear (Steel) Wheel.
