DURABILITY TEST OF TRUCK,

UTILITY, 1/4-TON, 4 BY 4, M151

DEVELOPMENT AND PROOF SERVICES

First Report

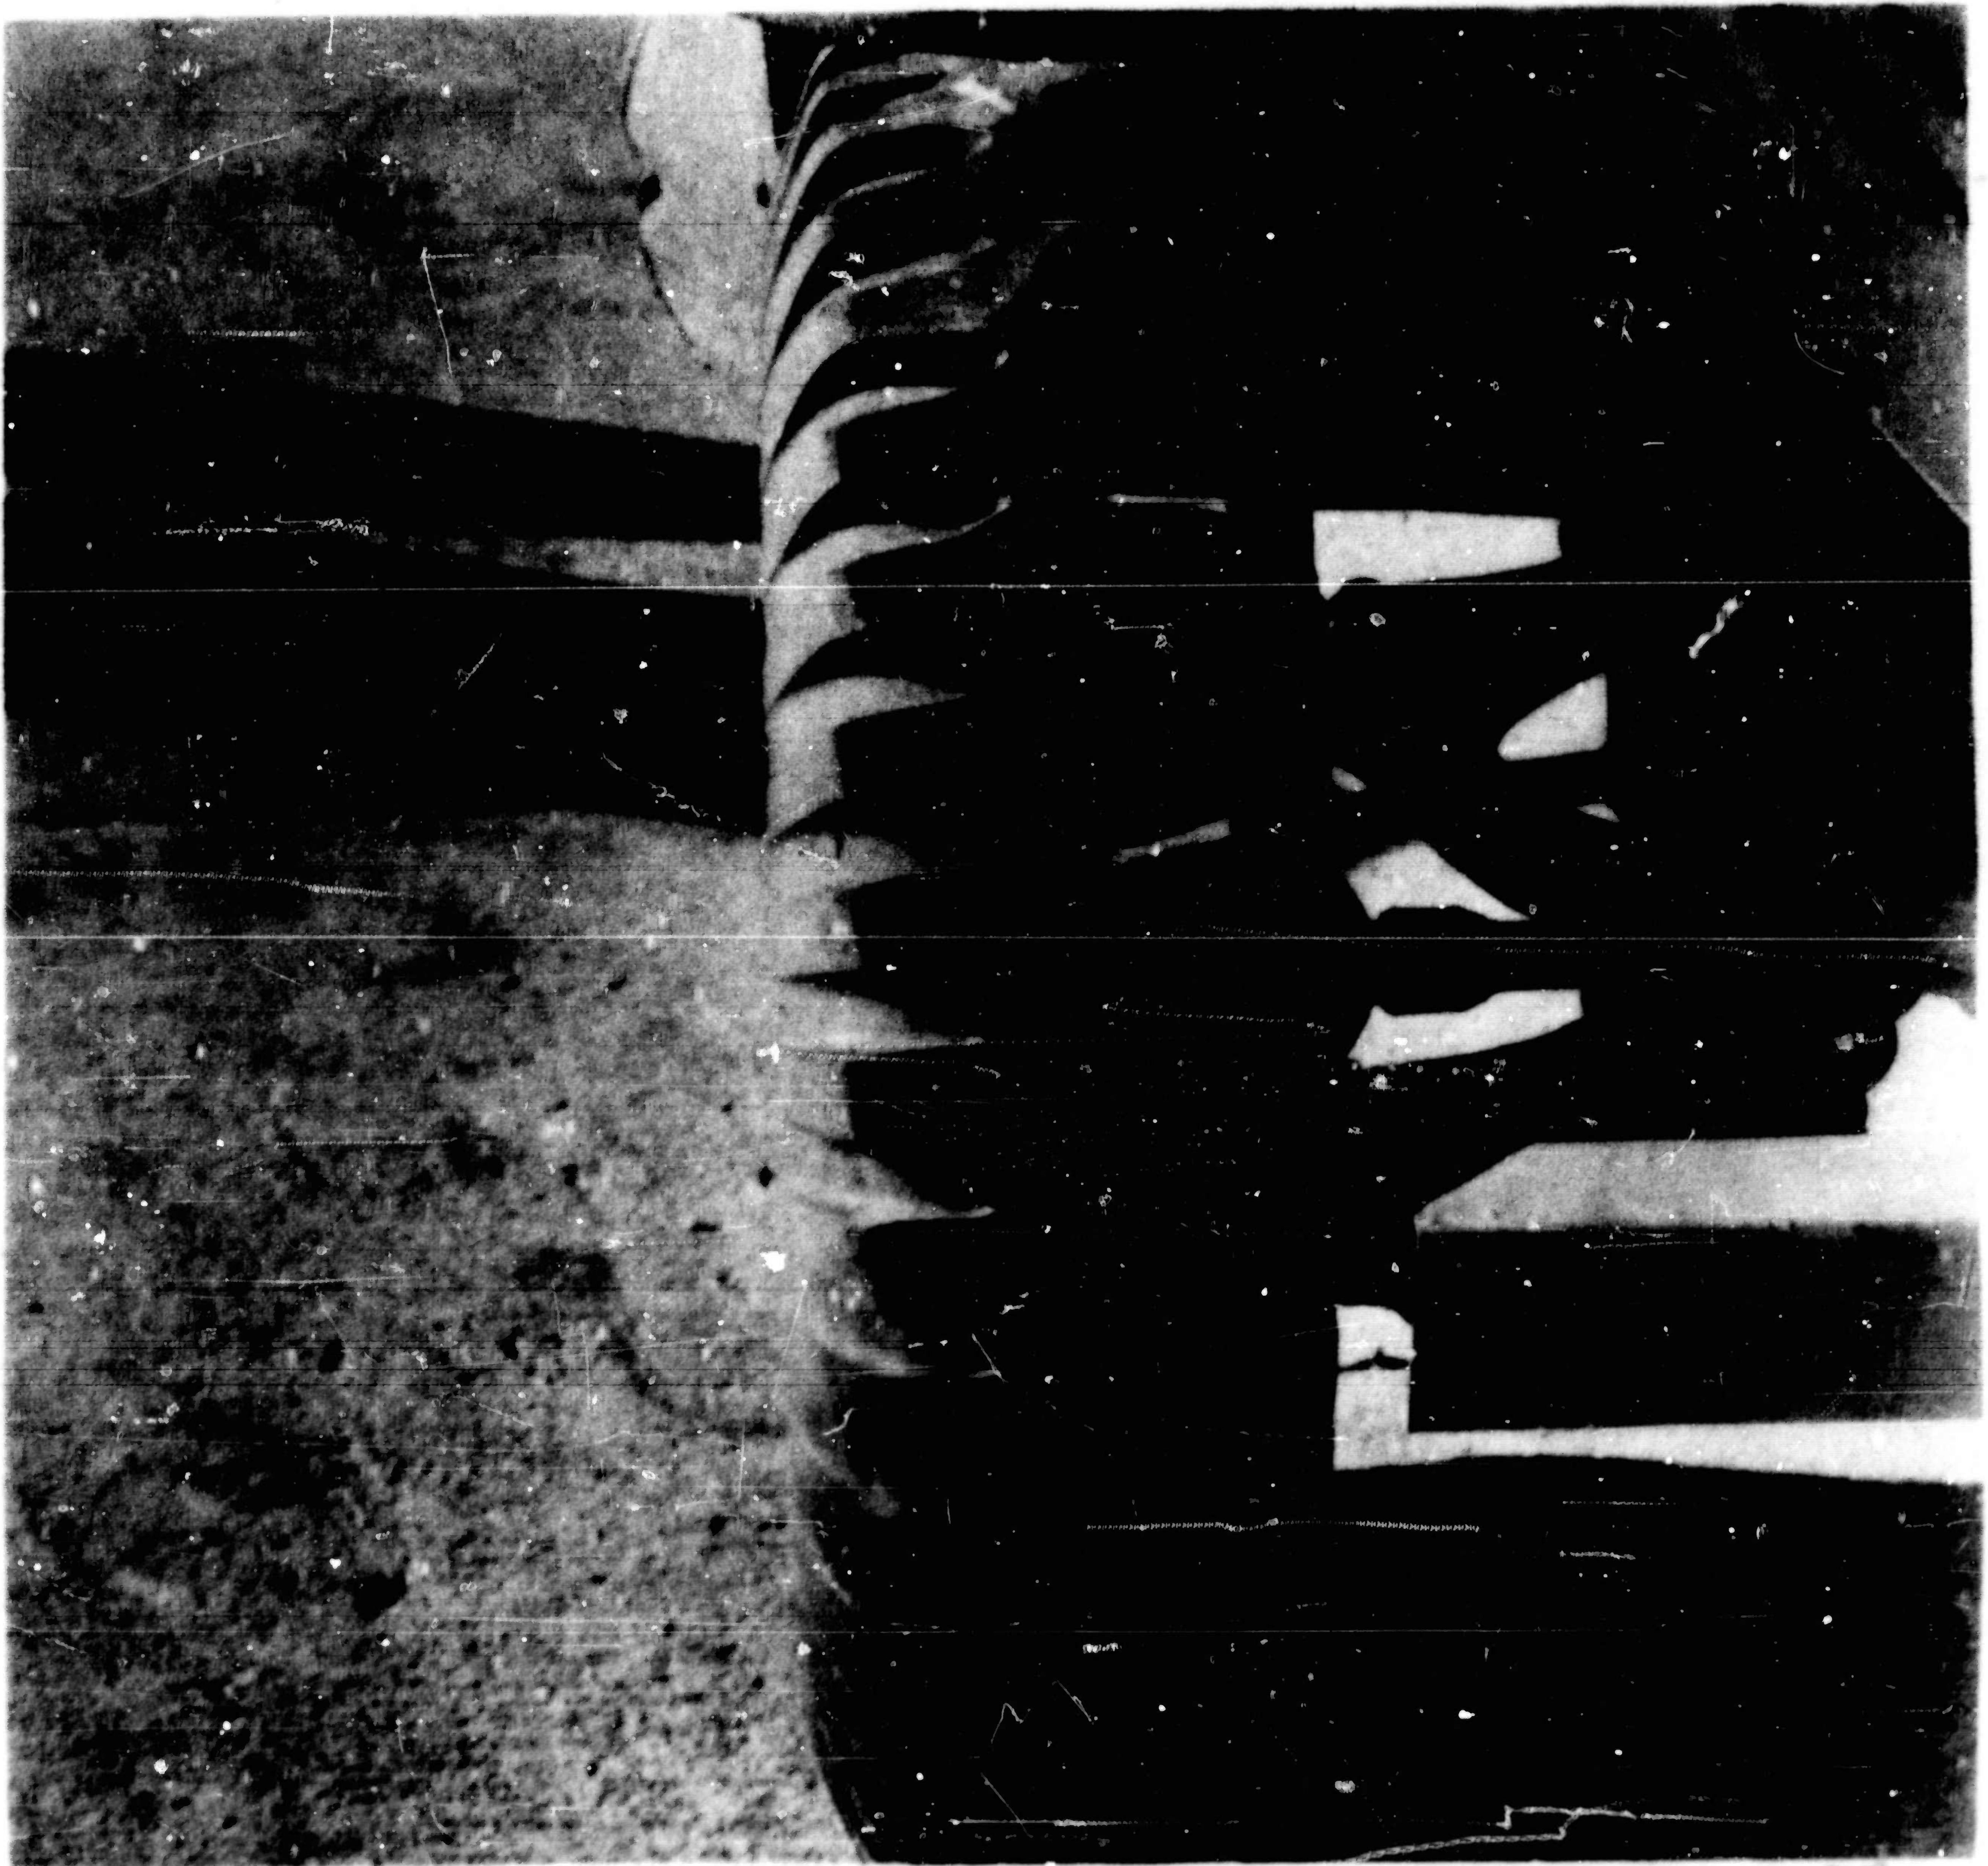
Odometer 13'86 - Due to the excessive tire wear, new nylon light-weight tires were installed and front tire inflations were increased 5 psi to 20 psi and rear tires were inflated to 25 psi (as during previous tests). Figure 35 shows characteristic wear of front tires after 5,000 miles of paved operation.

Figure 35 - B27994: Condition of Lightweight Nylon Tire after 5000 Miles of Paved Operation at Right Front Position with 20 psi Inflation Pressure.

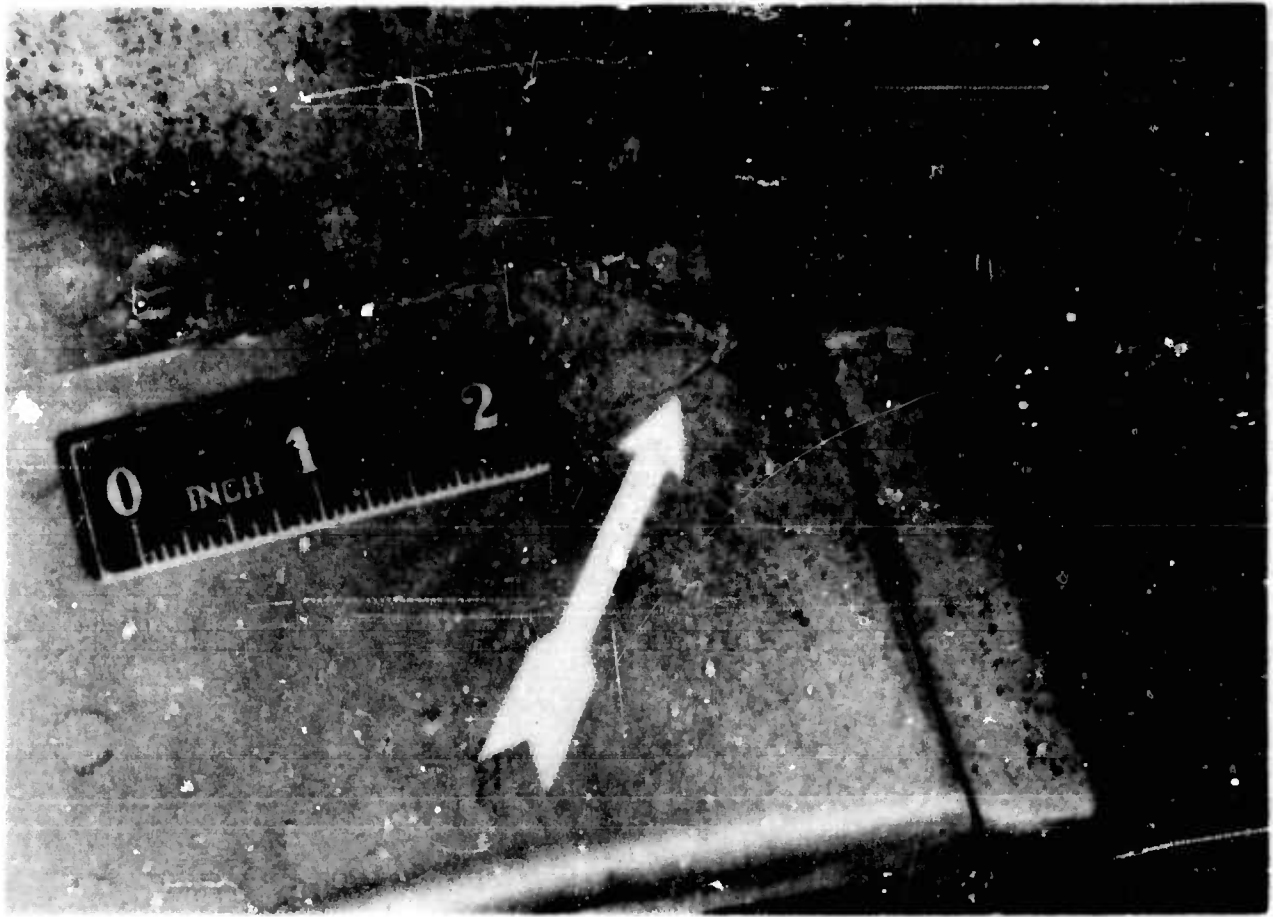
Figure 36 - B28805: Crack in Outer Right Frame Rail.

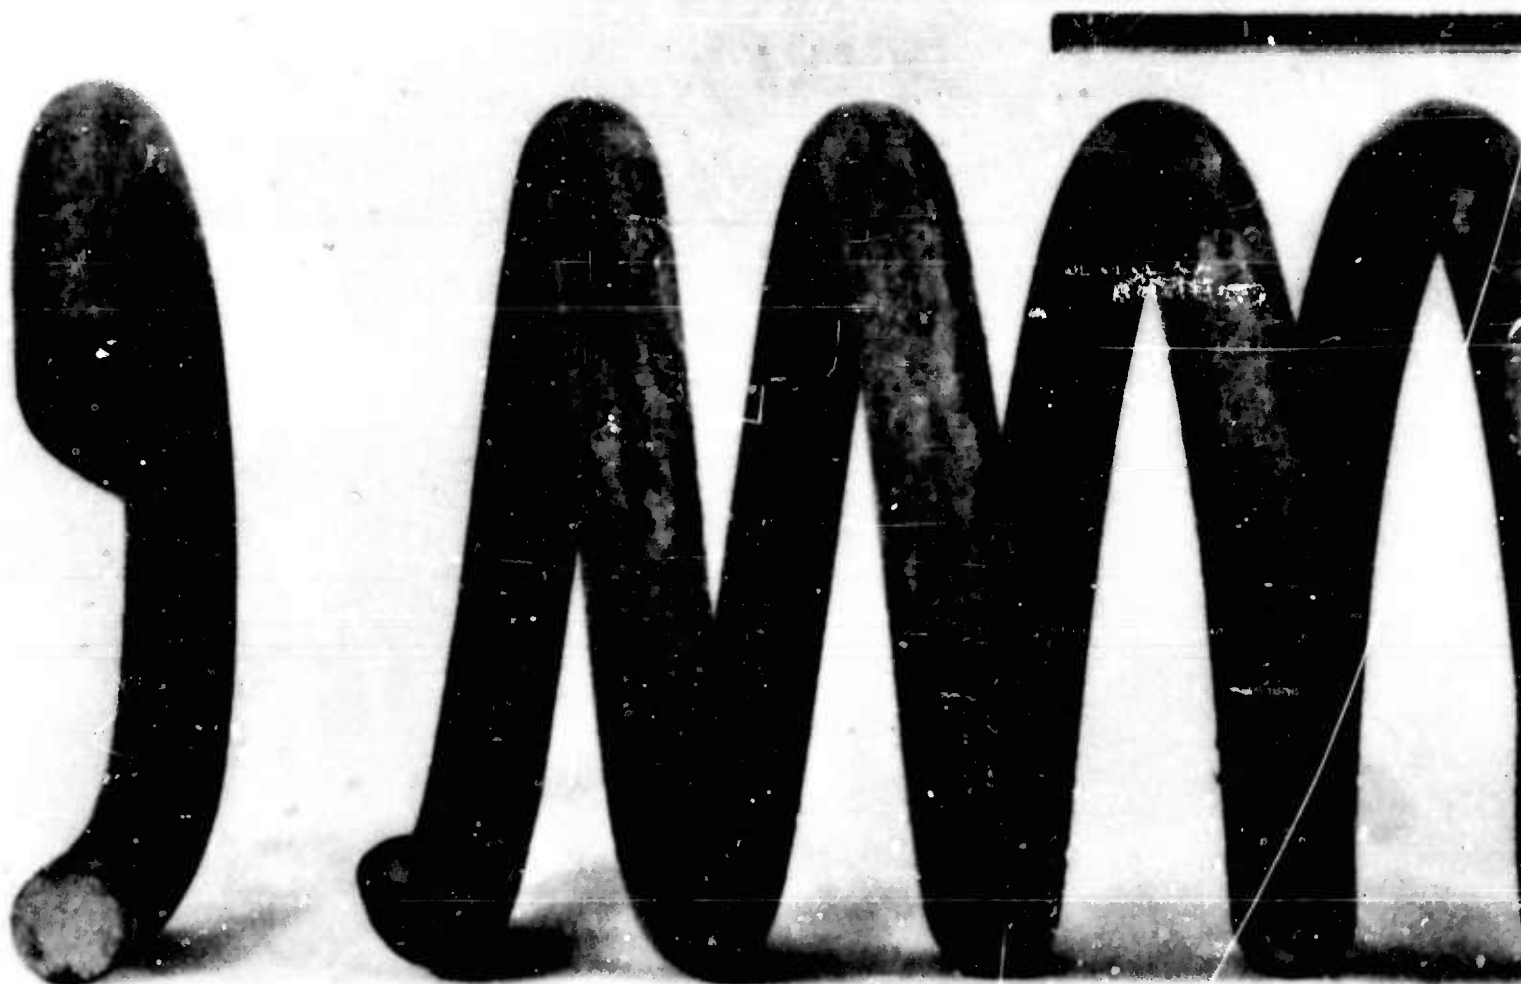
Odometer 11329 - During disassembly of right rear suspension it was disclosed that the lower coil of the spring was broken (Fig. 42).

Figure 42 - B27629: Broken Right Rear Coil-Spring.

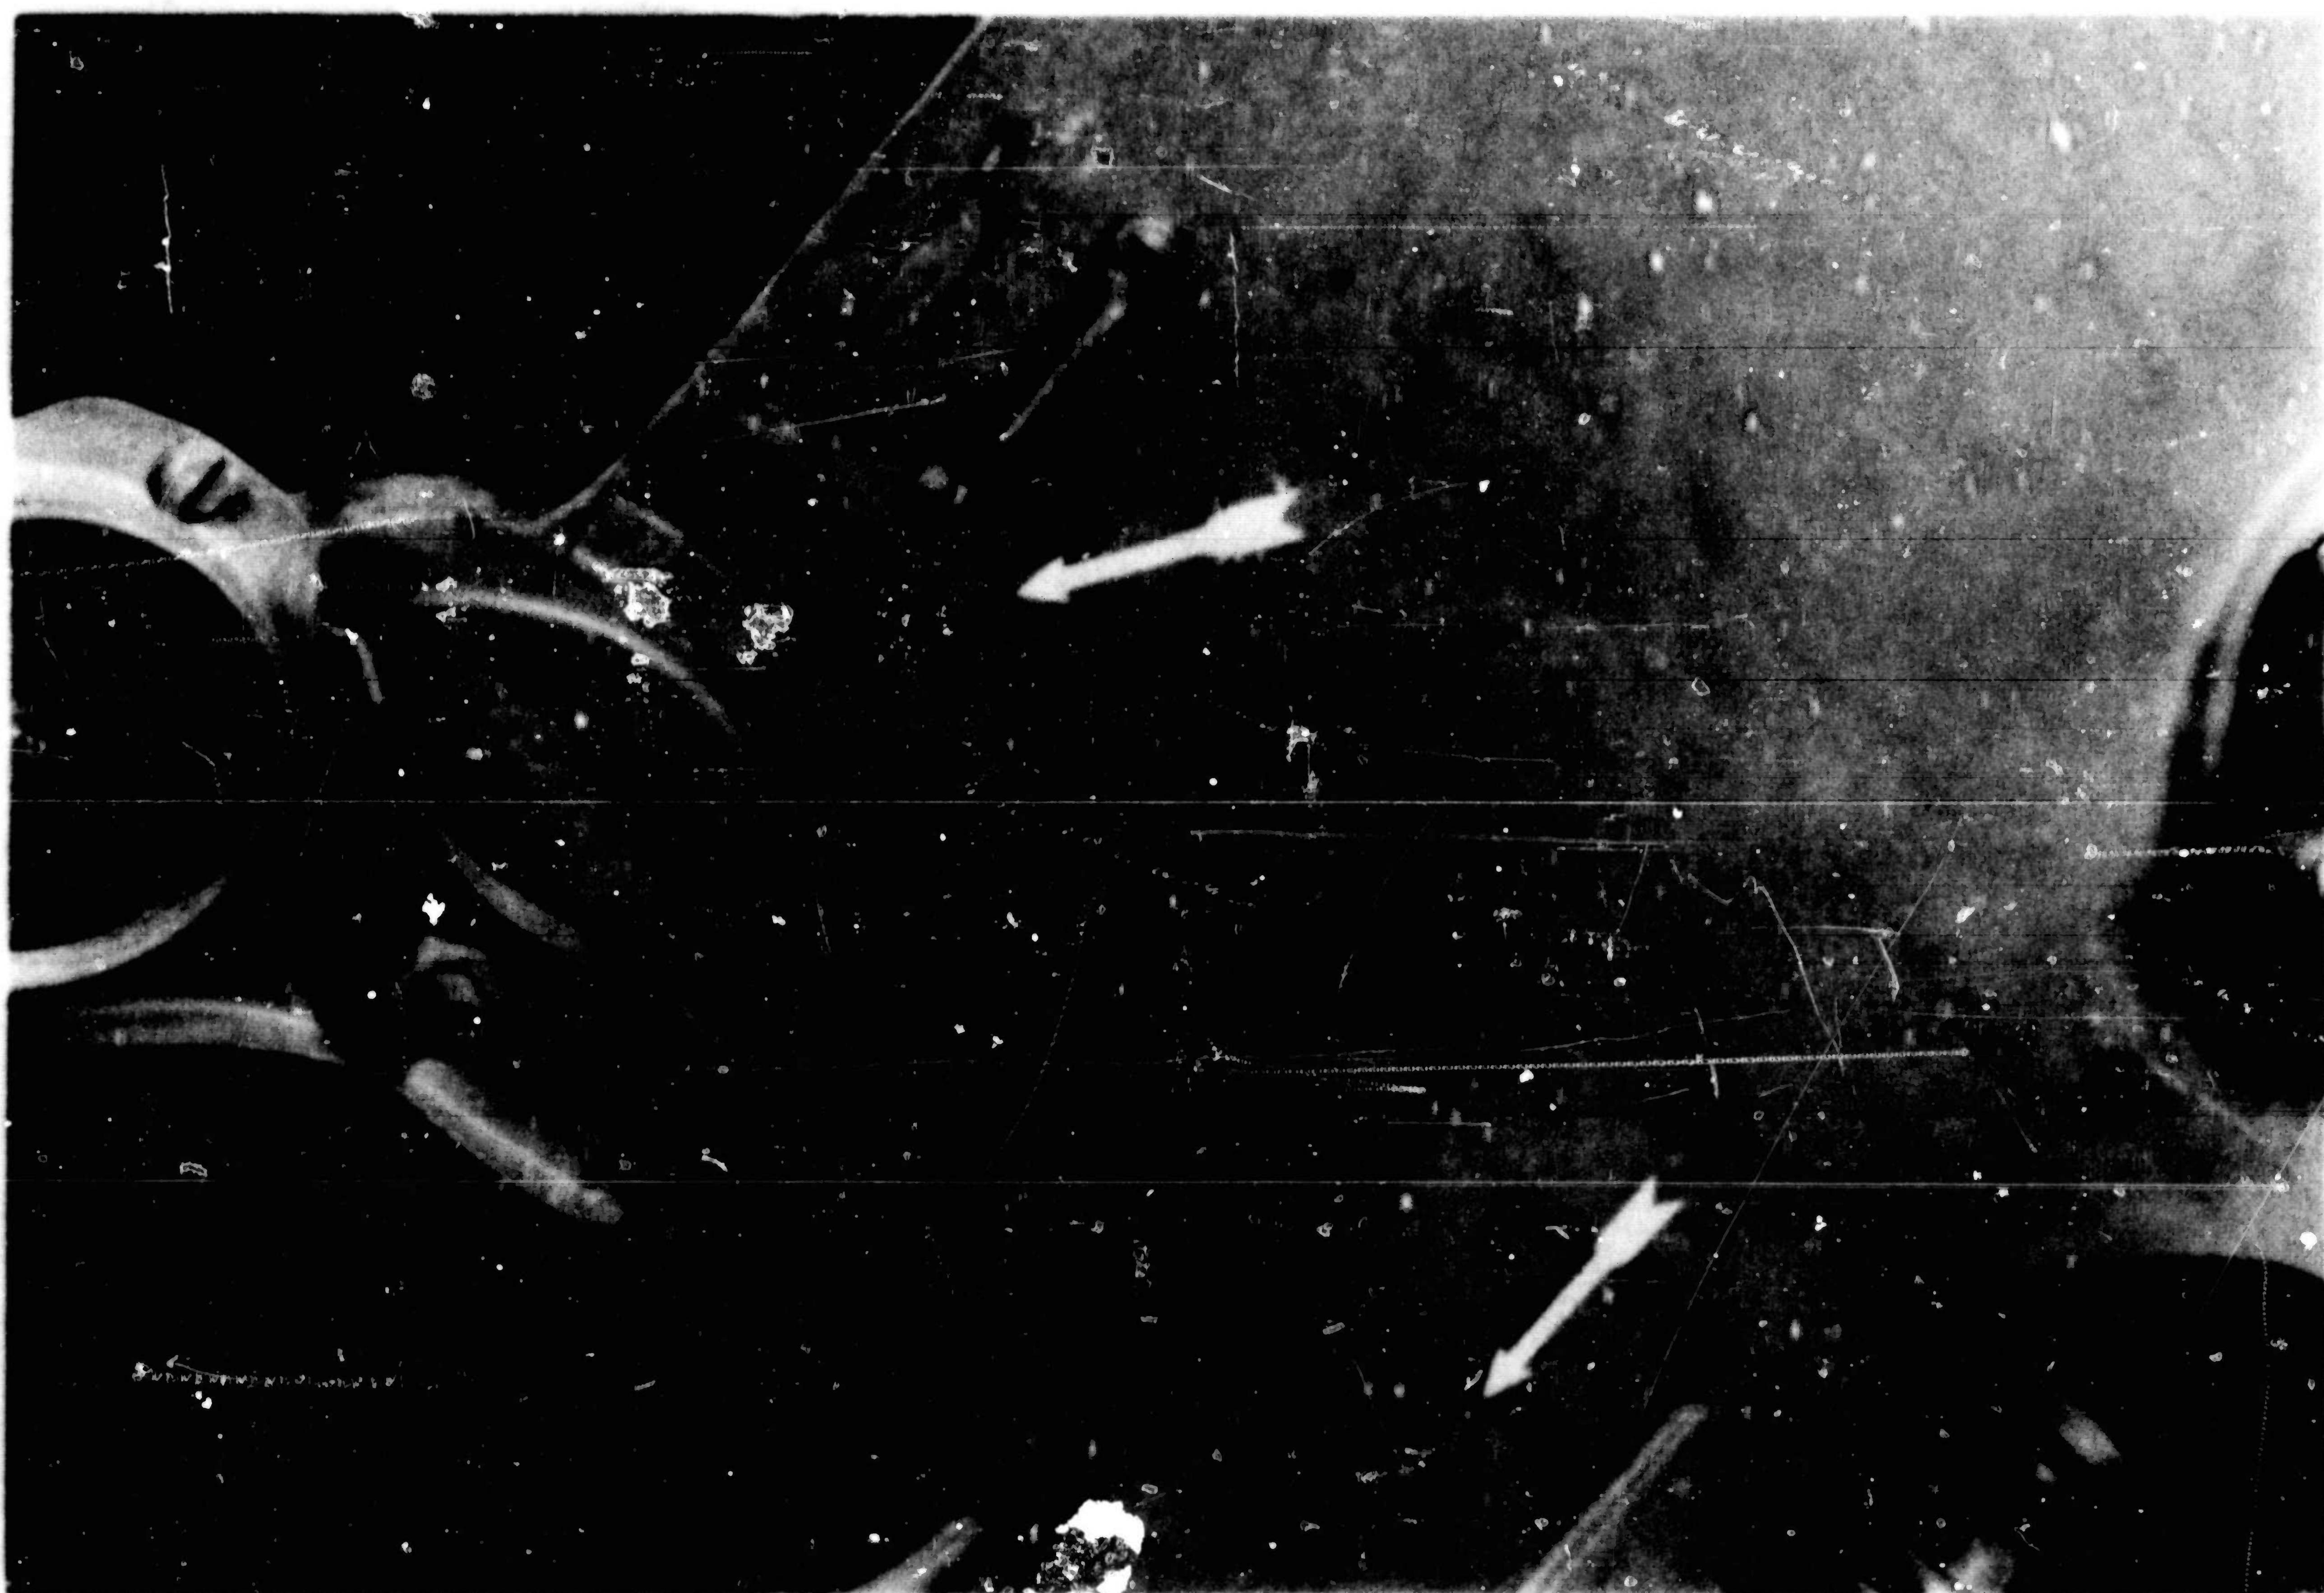
Odometer 1761 - The spare tire mounting bracket developed a crack starting in the mounting bracket reinforcement and extending into the rear panel of the body. At odometer 14,160 it was necessary to remove the tire to prevent extensive damage to the panel. Figure 44 shows extent of cracks in the bracket and panel at odometer 22,911.

Figure 44 - B28791: Spare Tire Mounting Bracket.

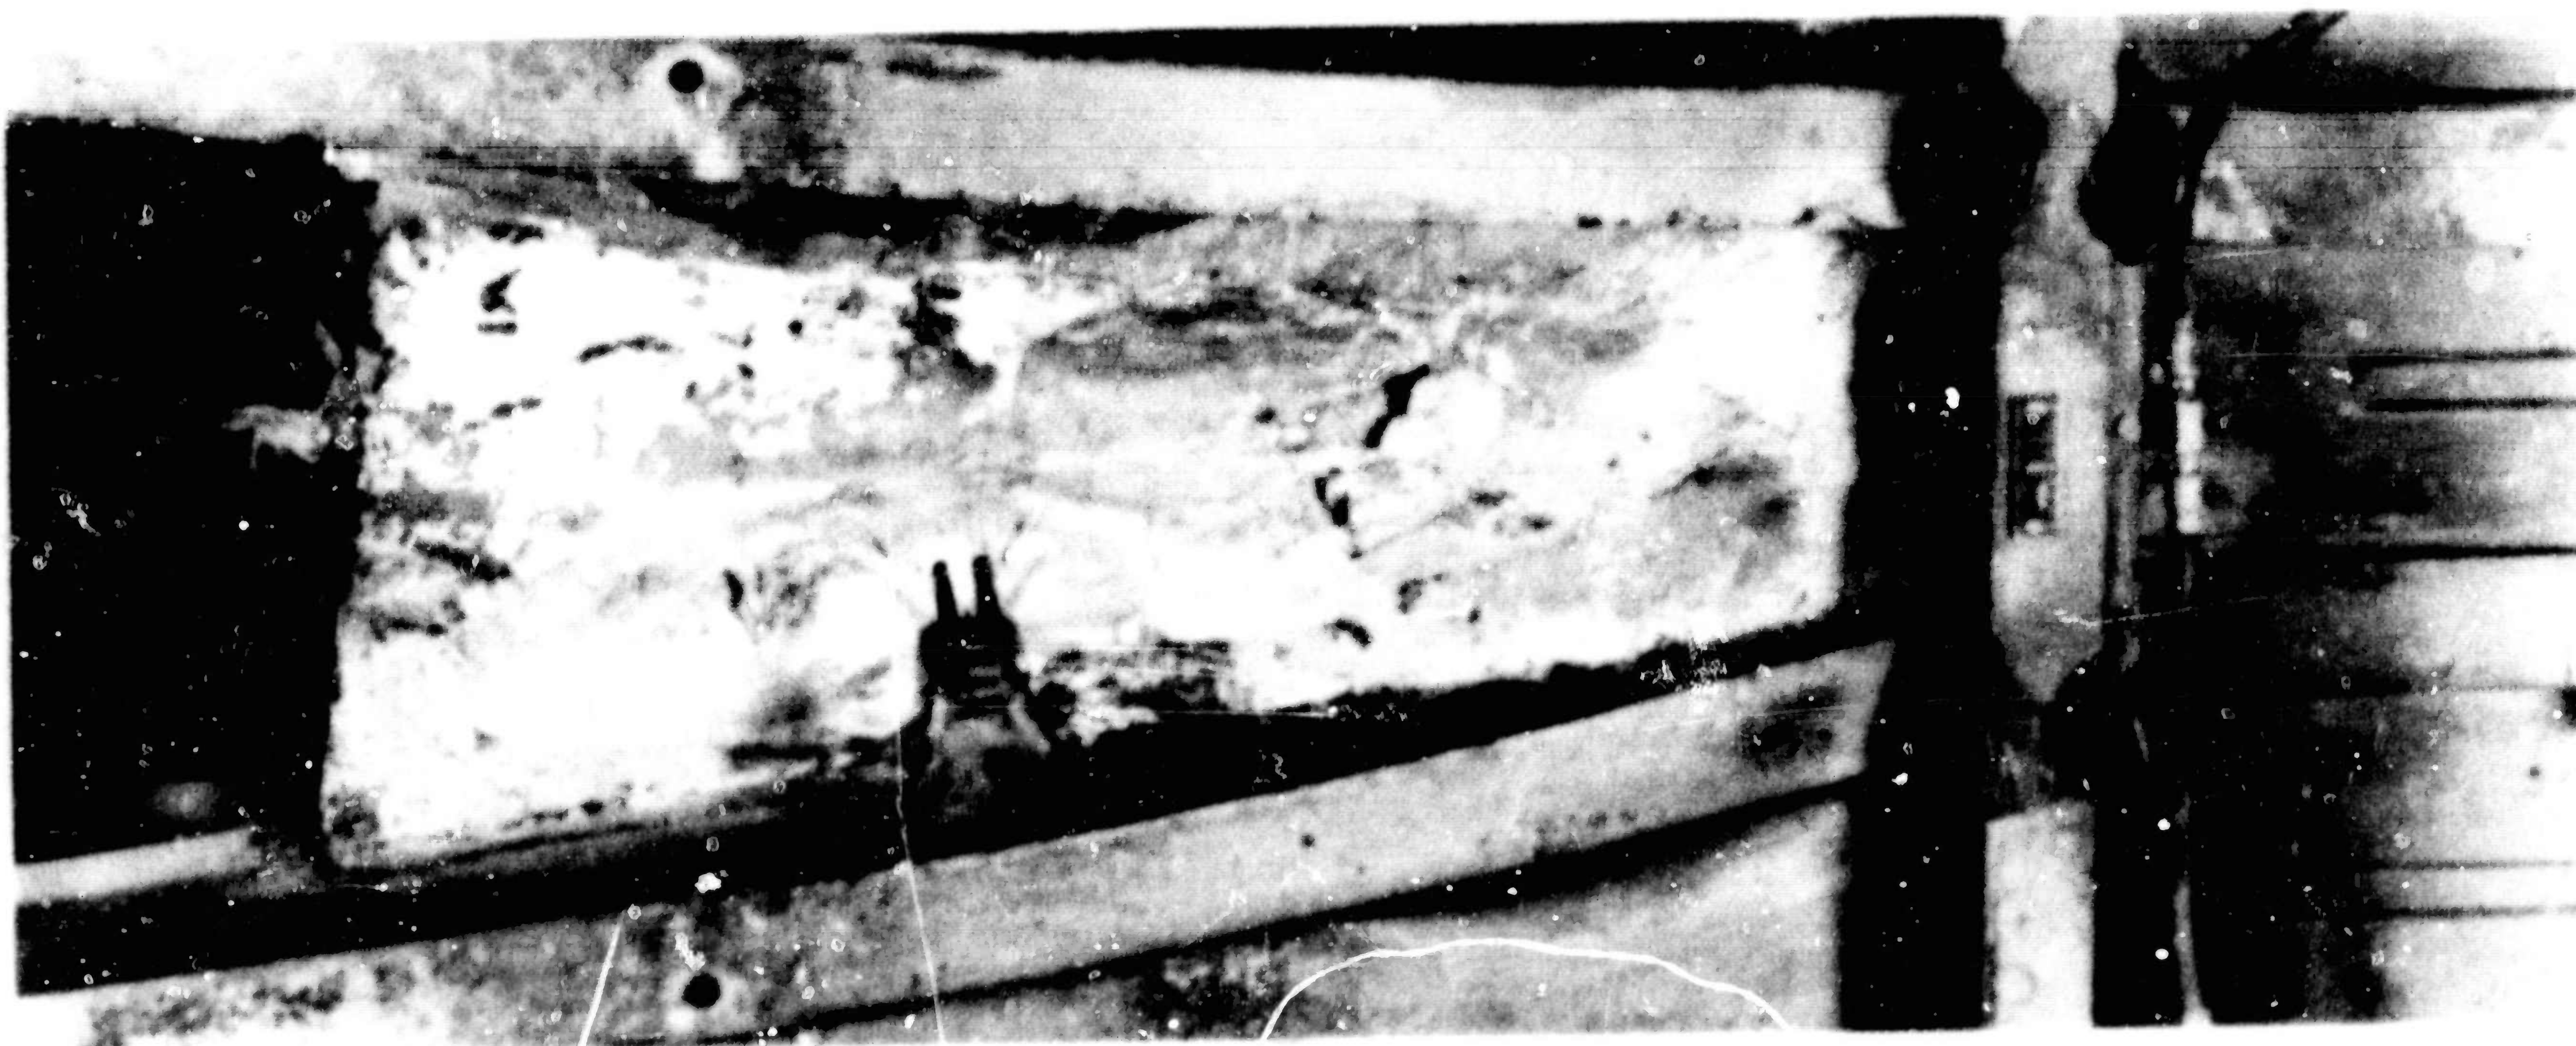
The insulation provided in the propeller shaft tunnel reduced the heat in the driver's compartment, however, the insulation was damaged during operation (Fig. 53).

Figure 53 - B28797: Damaged Condition of Insulation in Propeller Shaft Tunnel at Conclusion of Test.
