INITIAL PRODUCTION TEST

TRUCK, UTILITY, 1/4-TON, 4X4

M151A2

FINAL REPORT

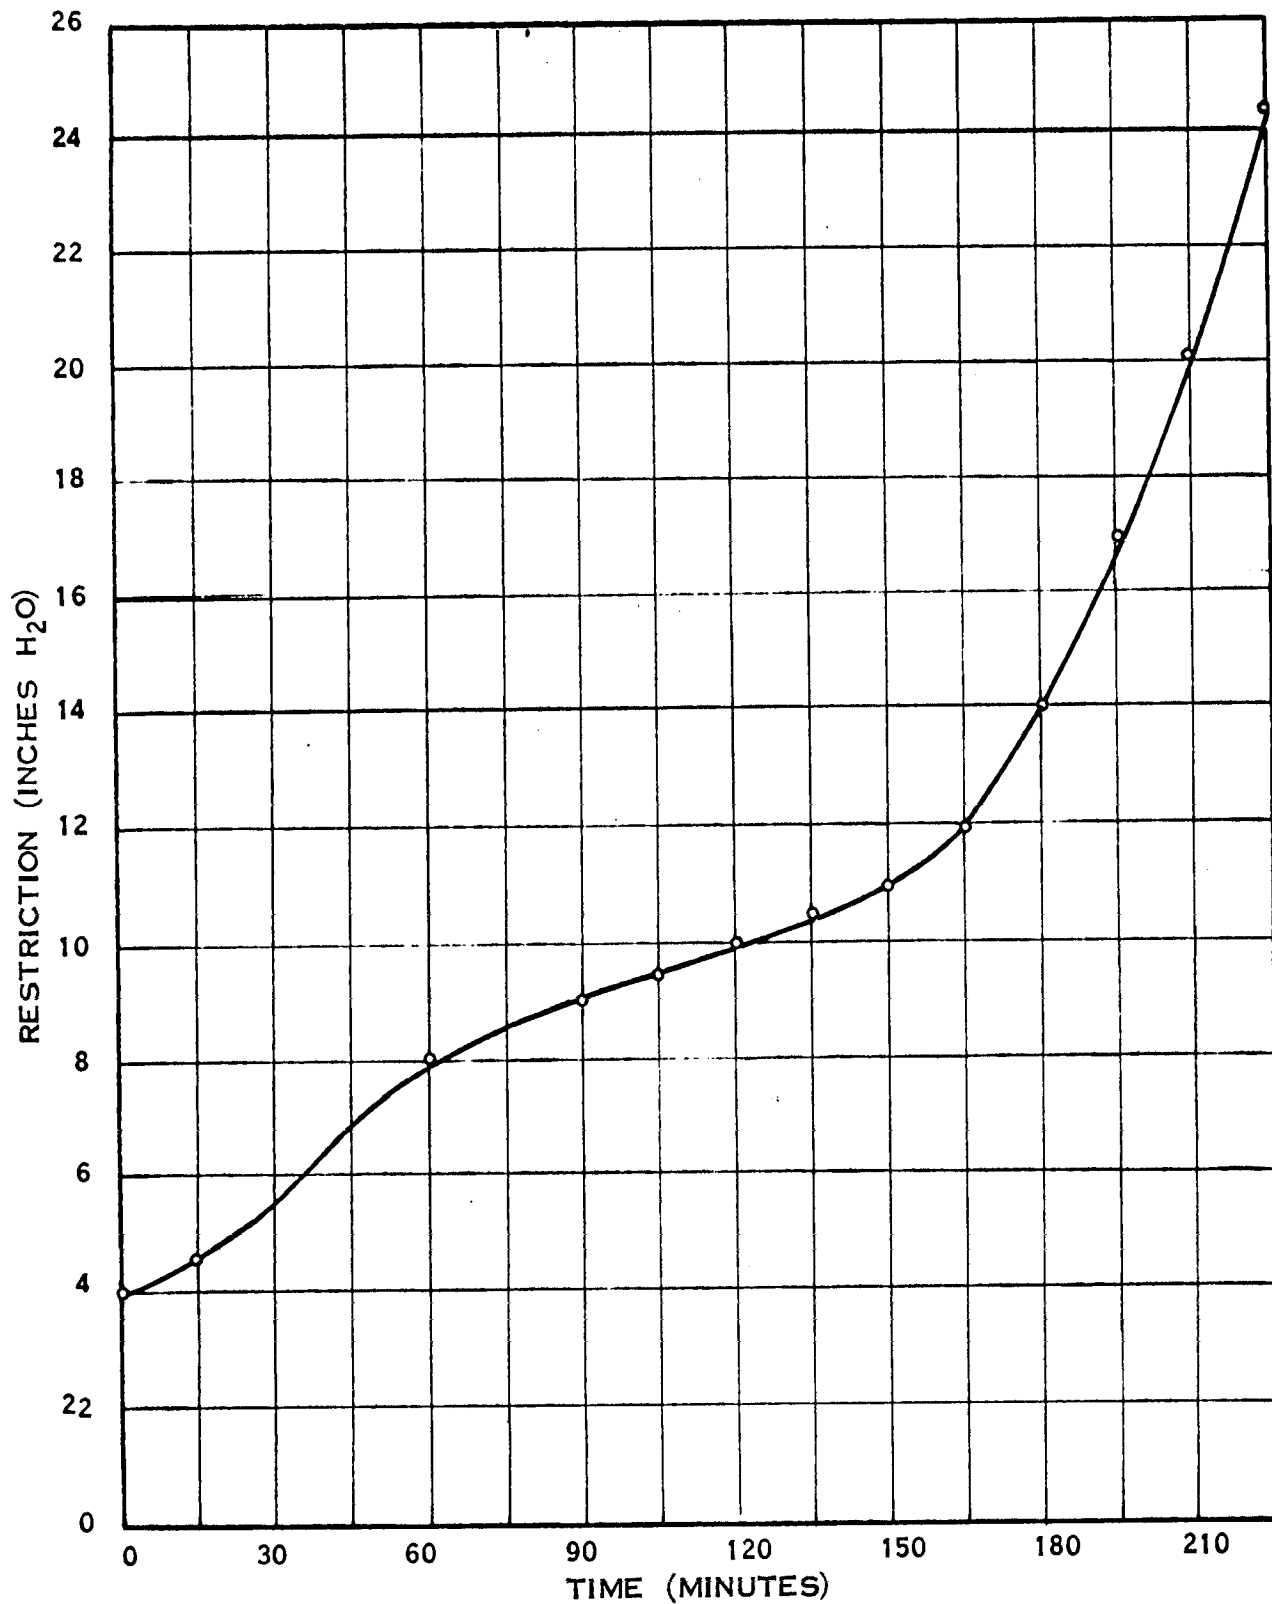
2.5.4.2 Extreme Dust Condition. The air cleaner reached maximum restriction after 3.75 hours of operation in extreme dust. The air cleaner component weights before and after test are presented in Table 12.

FIGURE 1. AIR CLEANER RESTRICTION CHARACTERISTICS DURING DUST TESTS, VEHICLE NO. 02DU8370, 27 JUNE 70.

2.5.5.2 Air cleaner Functioning. Military Standard MIL-A-13488A(Ord) specifies a test of 24 inches of water to determine dust capacity. The extreme dust test was run to simulate the laboratory test condition. The lack of oil in the cleaner at the end of test indicates that the air cleaner had ceased to function properly sometime before the 24-inch restriction was attained, and unfiltered air was entering the engine. The oil level was such that oil was lost by being "pulled over" into the engine. The restriction versus time graph in Figure 1 indicates the possibility that the air cleaner probably lost its effectiveness after 2.5 hours of operation at a restriction of 11 inches of water, as evidenced by the rapid rate of rise after that point.

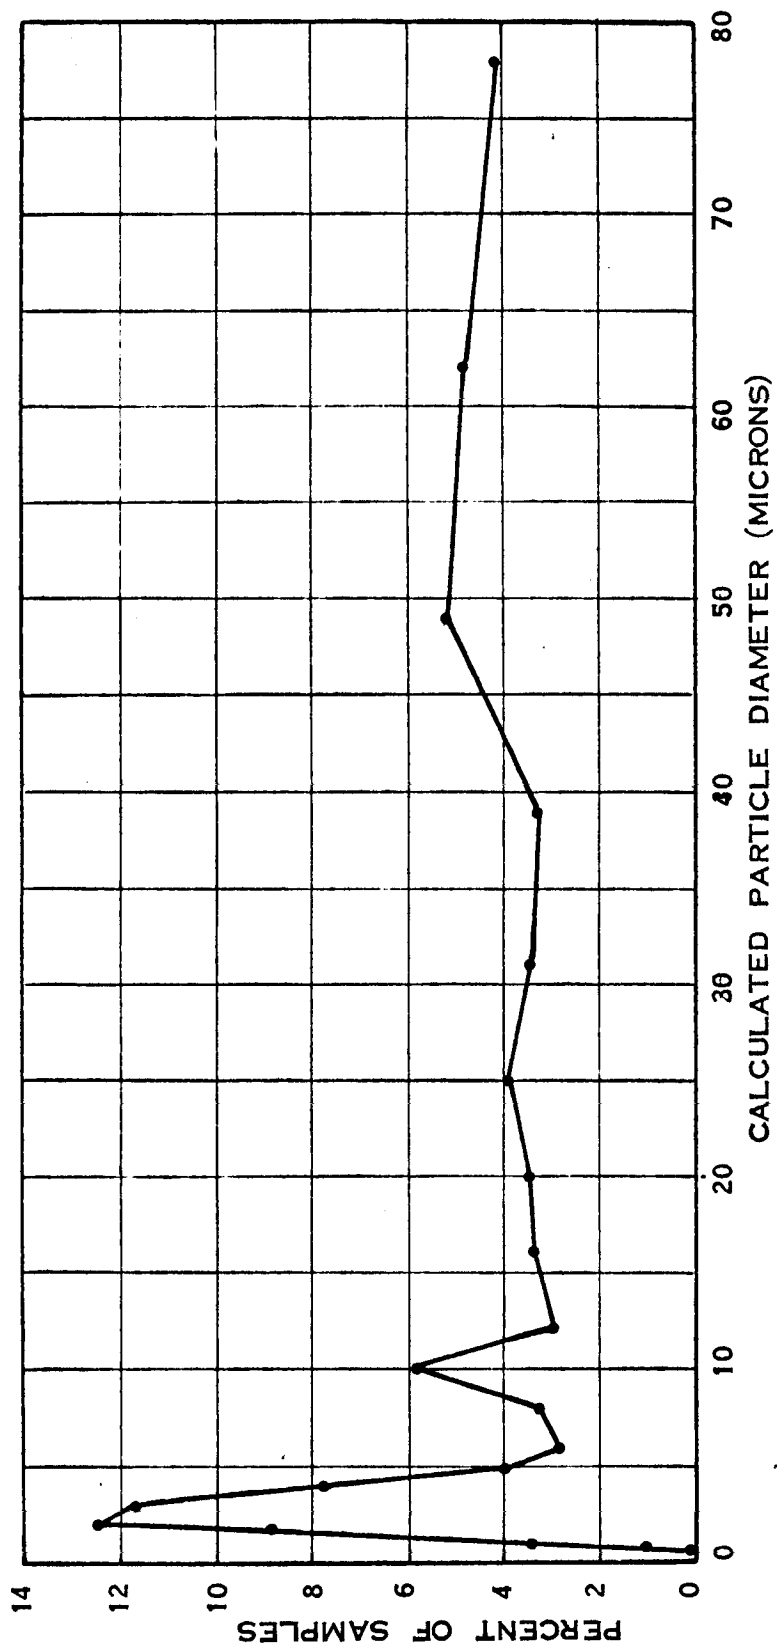
Dust deposits were also observed on the electrodes of all four spark plugs. The inside air duct hose from the air cleaner to the carburetor was covered with dust and a sample was analyzed to determine the size of the particles that were being ingested into the engine. A graph of the distribution by size of these particles is shown in Figure 2. Detailed data are presented in Table 2 of Appendix I.6.

FIGURE 2. DISTRIBUTION BY PARTICLE SIZE OF DUST PARTICLES IN INTAKE AIR DUCT HOSE.

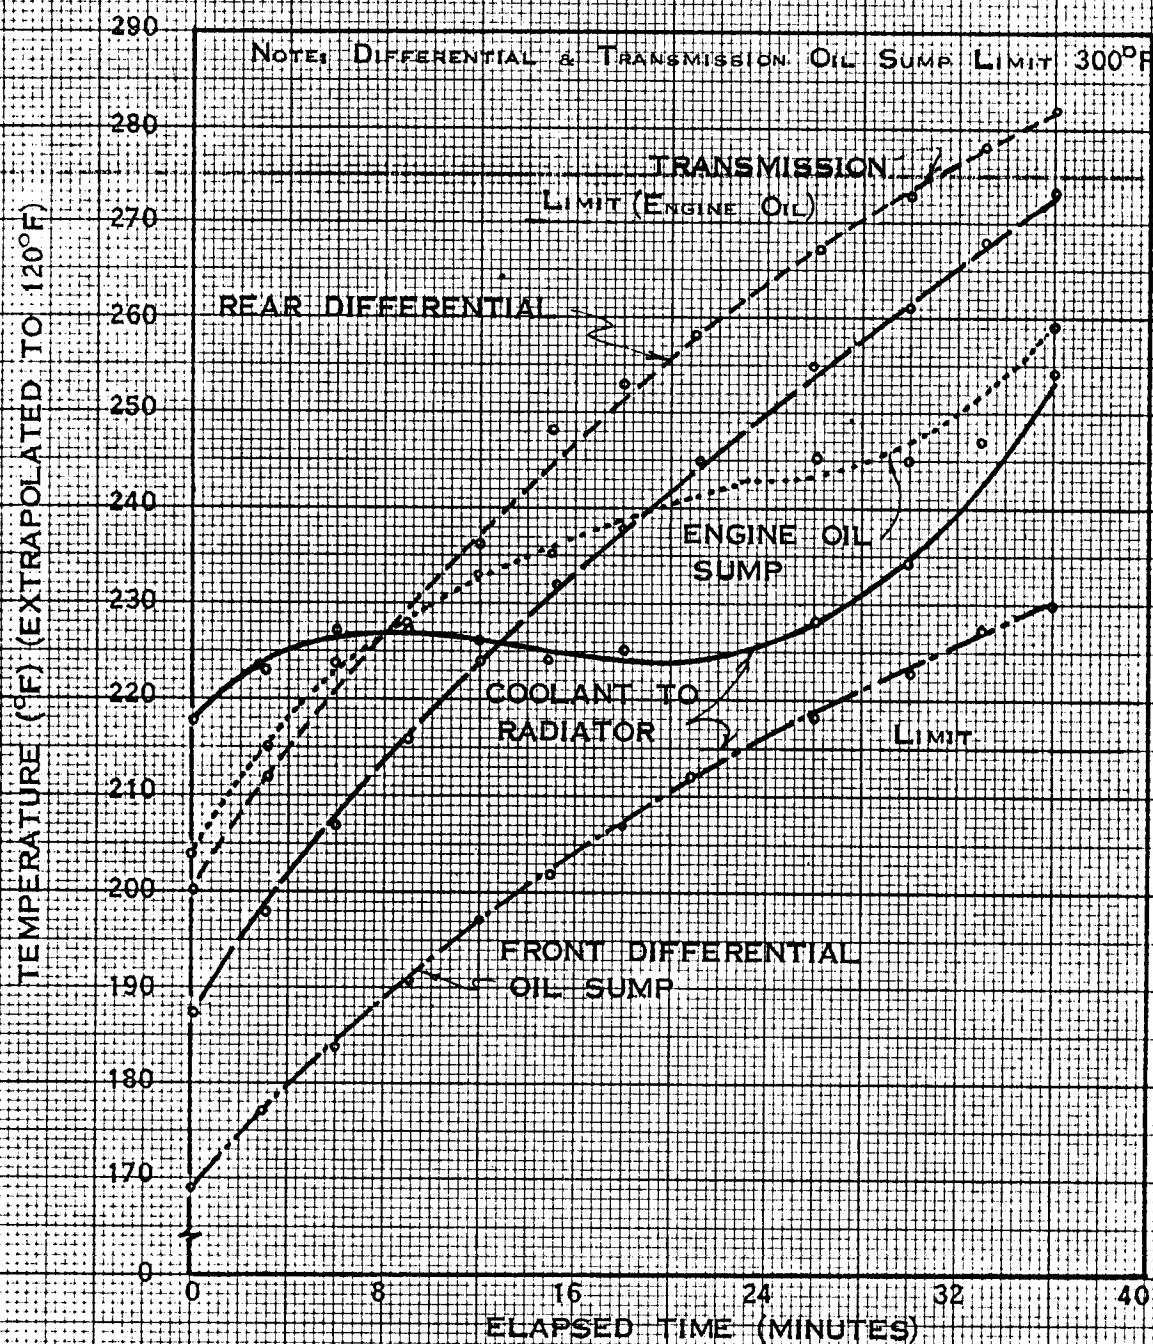
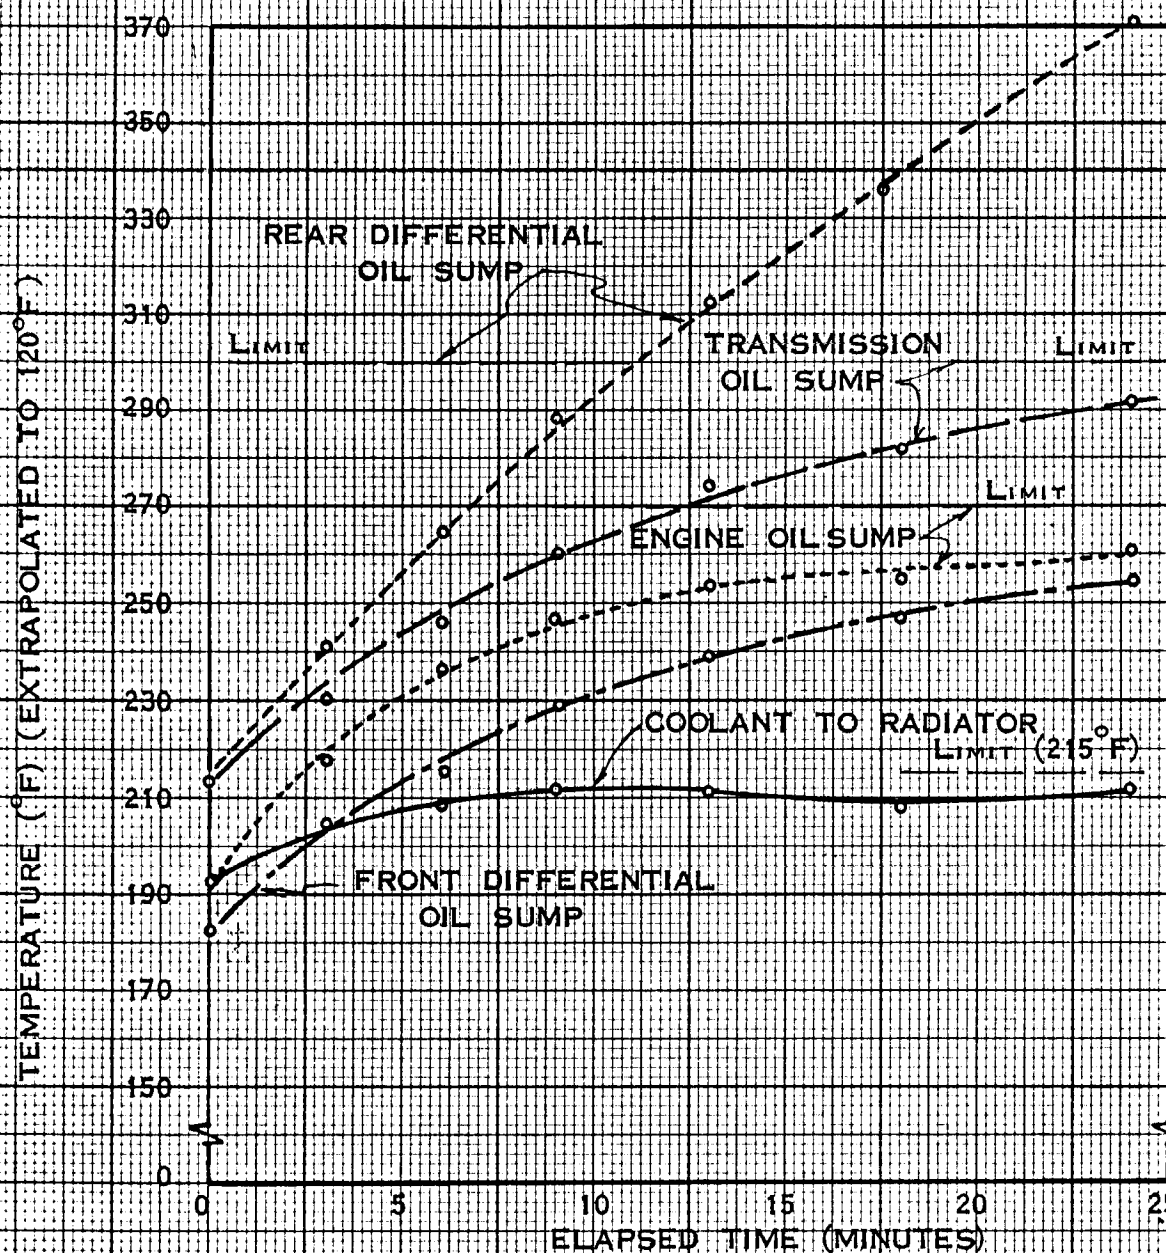
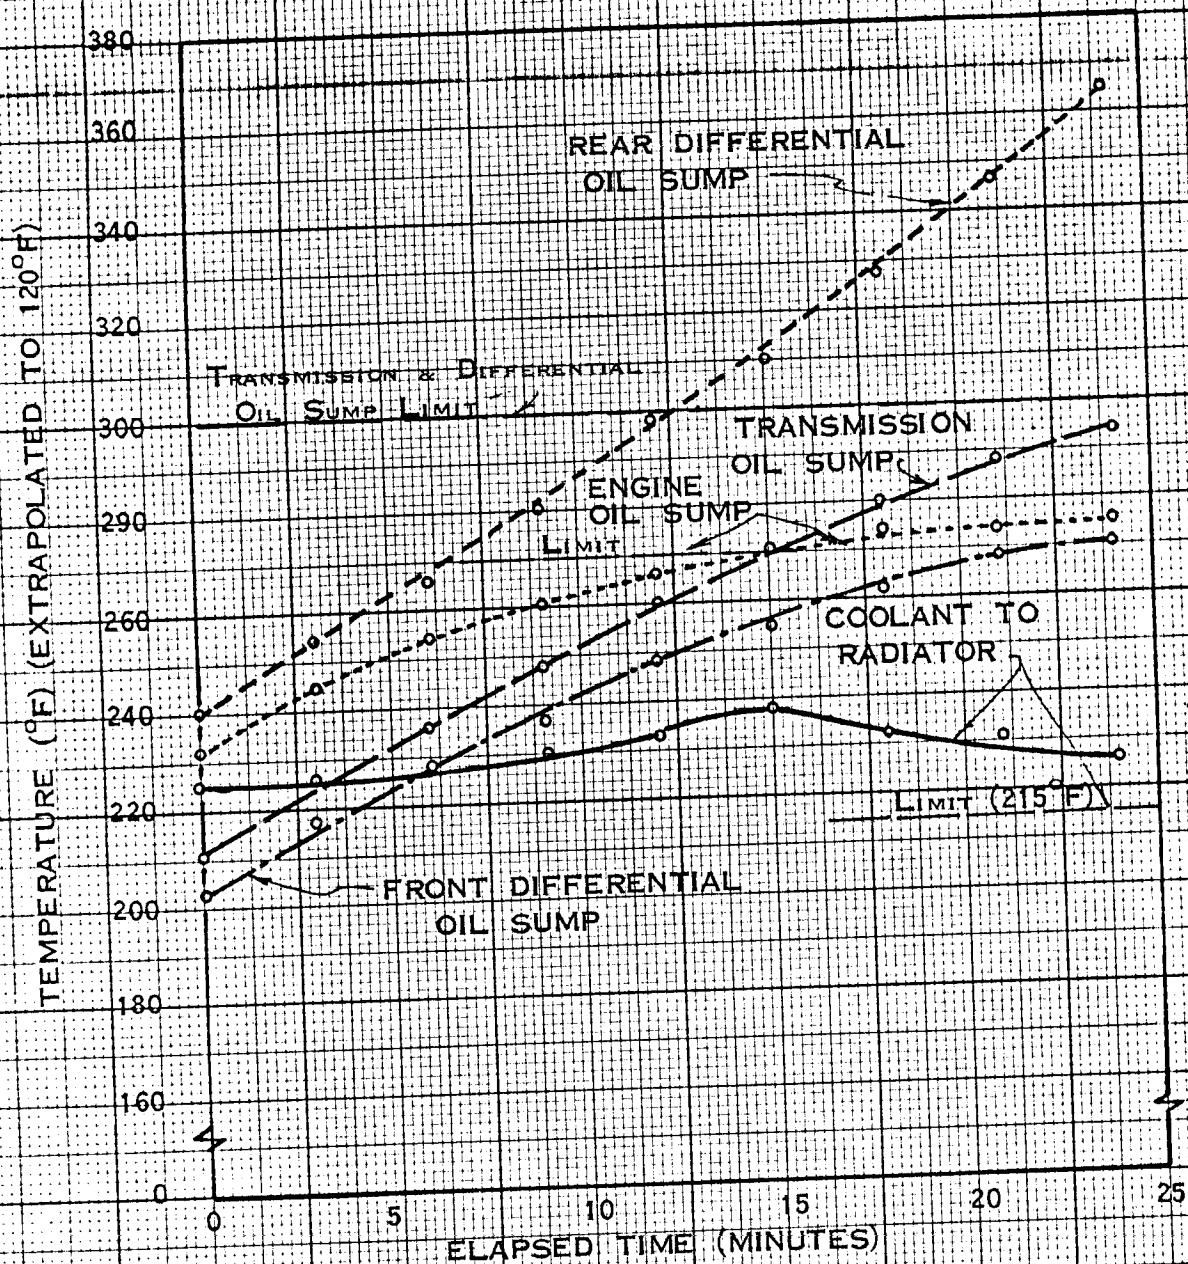
temperatures stabilized on this third run, but not before the rear differential reached its limit. Curves of the temperature rise for the front and rear differentials may be found in Figures 1, 2 and 3 of Appendix I.5. They indicate a temperature rise of 6°F/minute in the rear differential.

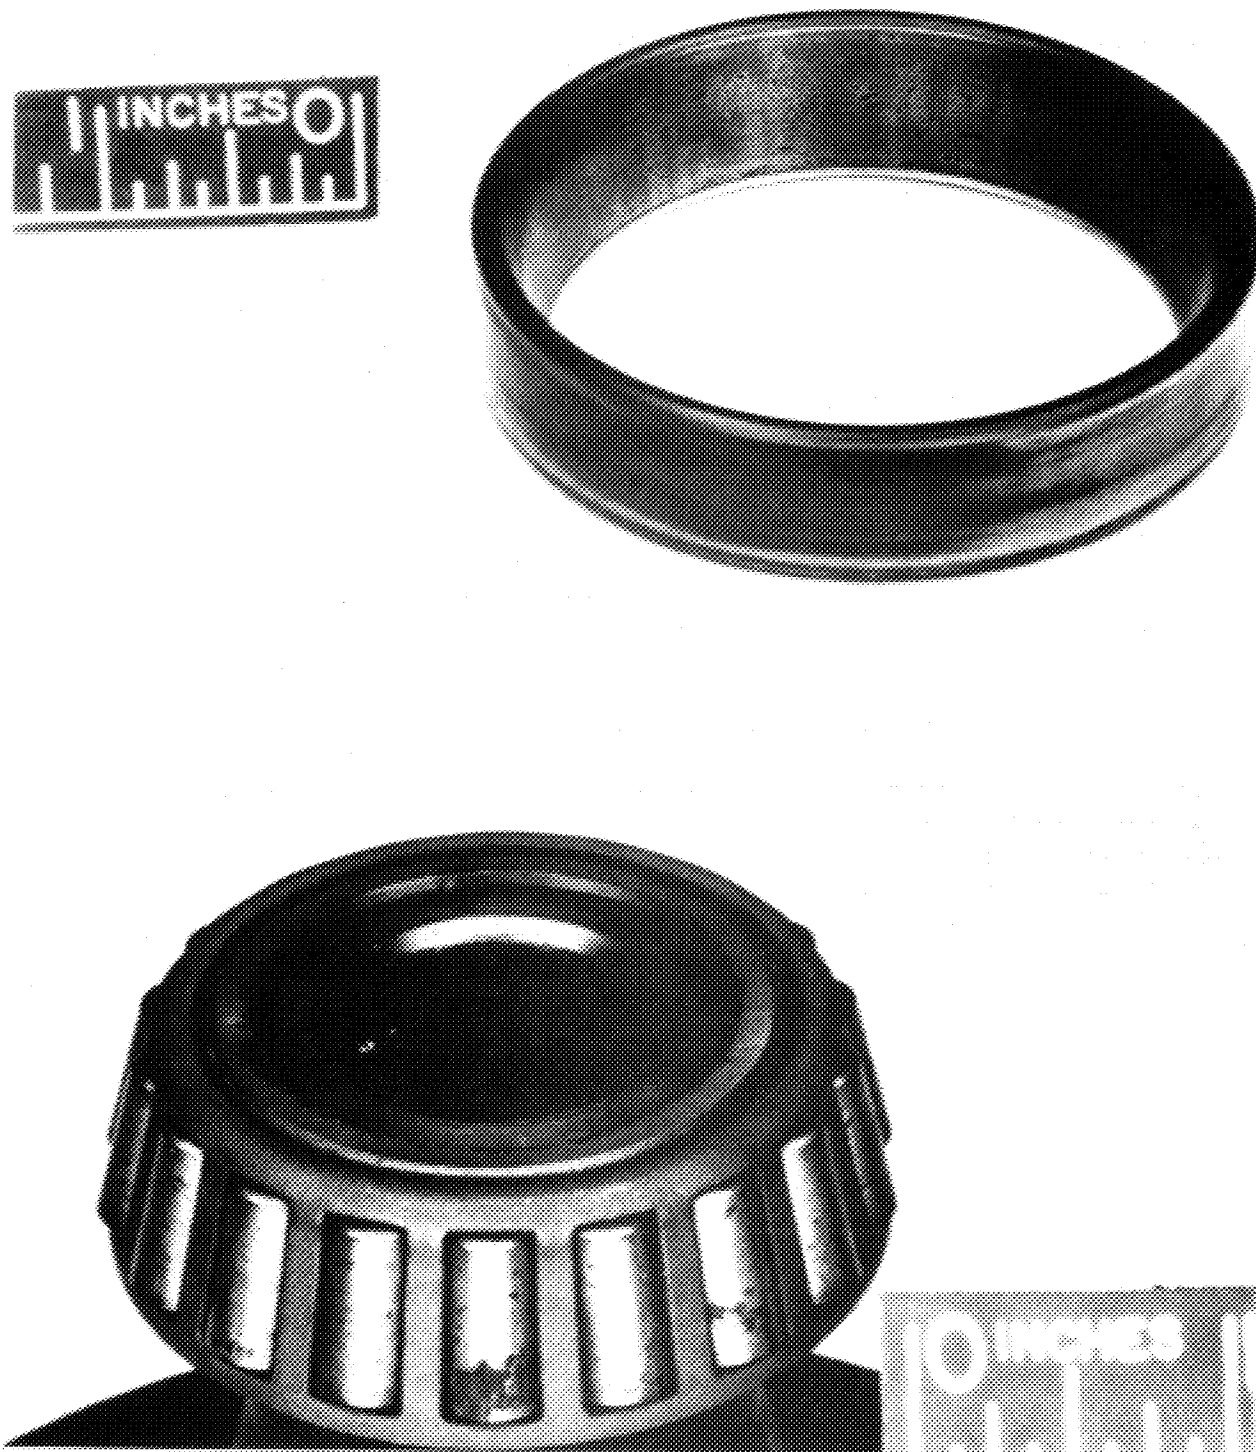
j. The rear differential of one vehicle had spalled rollers in the right output roller bearing. Both the bearing and its race were considered unserviceable.

FIGURE 1. Spalled right output roller bearing and race (02DU8170).

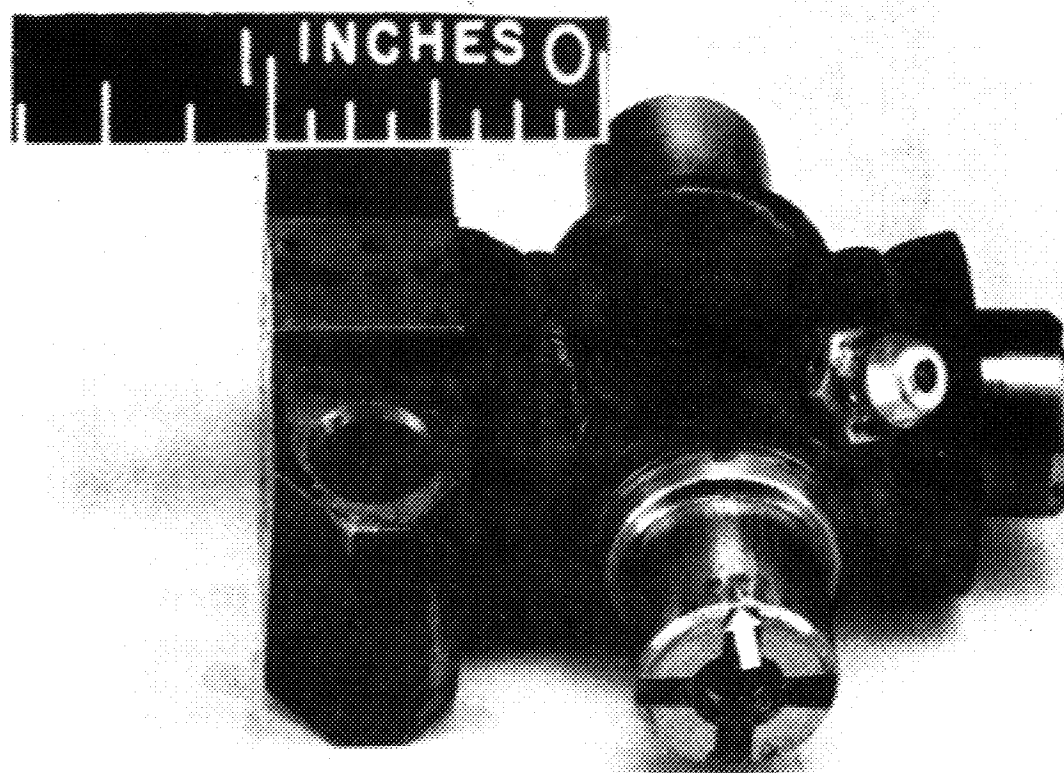
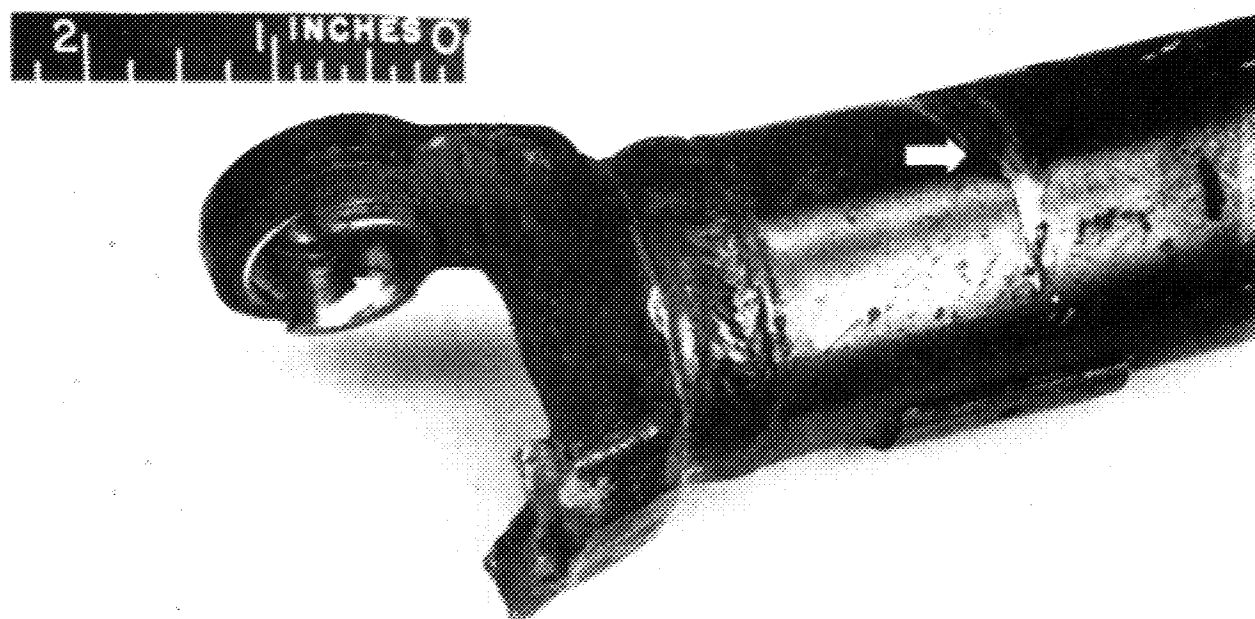
There were two deficiencies observed during durability-reliability operation. The first was a propeller shaft failure on vehicle U83 at 17,170 test miles. The rear yoke broke and disabled the vehicle. The second was extensive brake pulling and uneven application experienced by all vehicles after 12,000 to 15,000 miles.

The broken yoke on the propeller shaft was classified as a deficiency because the vehicle was disabled. The brake pulling, although not a serious hazard on YPG's dry pavement and gravel courses, would be extremely dangerous on wet or icy roads. This safety hazard is the basis for deficiency classification.

FIGURE 2. Railed rear yoke on propeller shaft (02DU8170).

- a. Quality control be improved.
- b. A-frame control arm bushing wear and propeller shaft breakage be further investigated and corrected.
- c. Brake problems be corrected.
- d. As many of the shortcomings as possible be corrected.

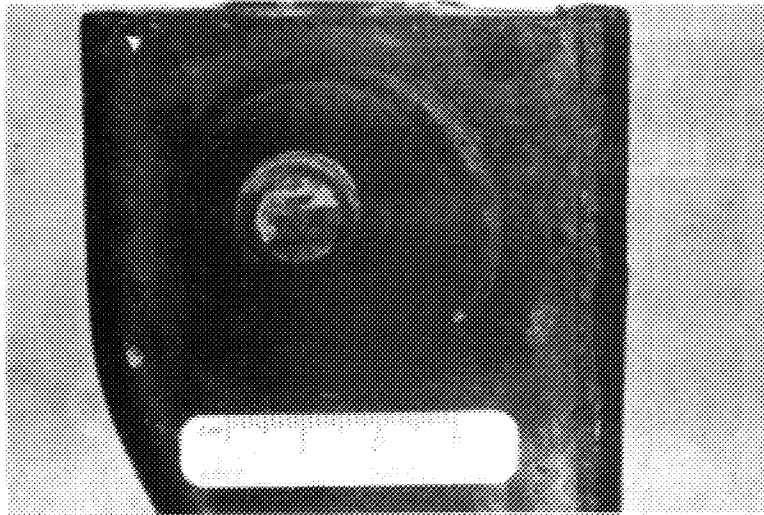
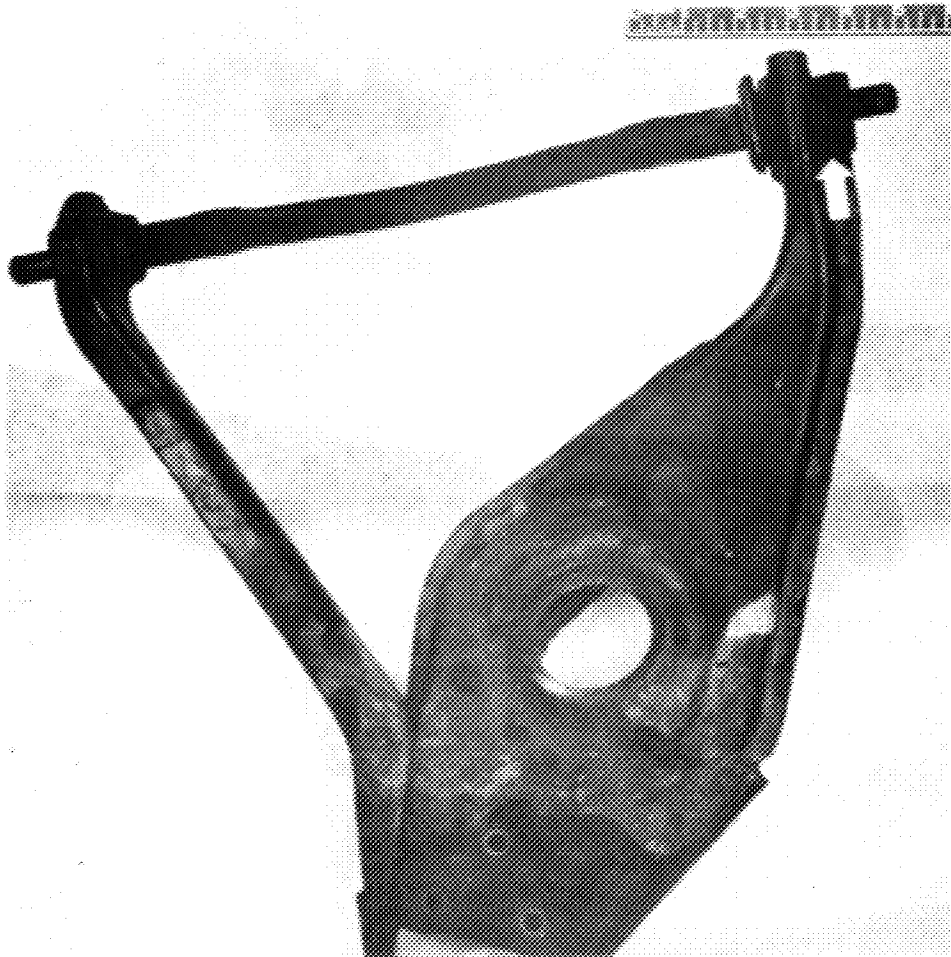
f. The bushings in the front upper and lower A-frame control arms were badly worn on all vehicles (Fig. 3, App I.9). Problem was discovered about 17,500 test miles (Group 13).

FIGURE 3. Failed A-frame control arm bushings (all vehicles).

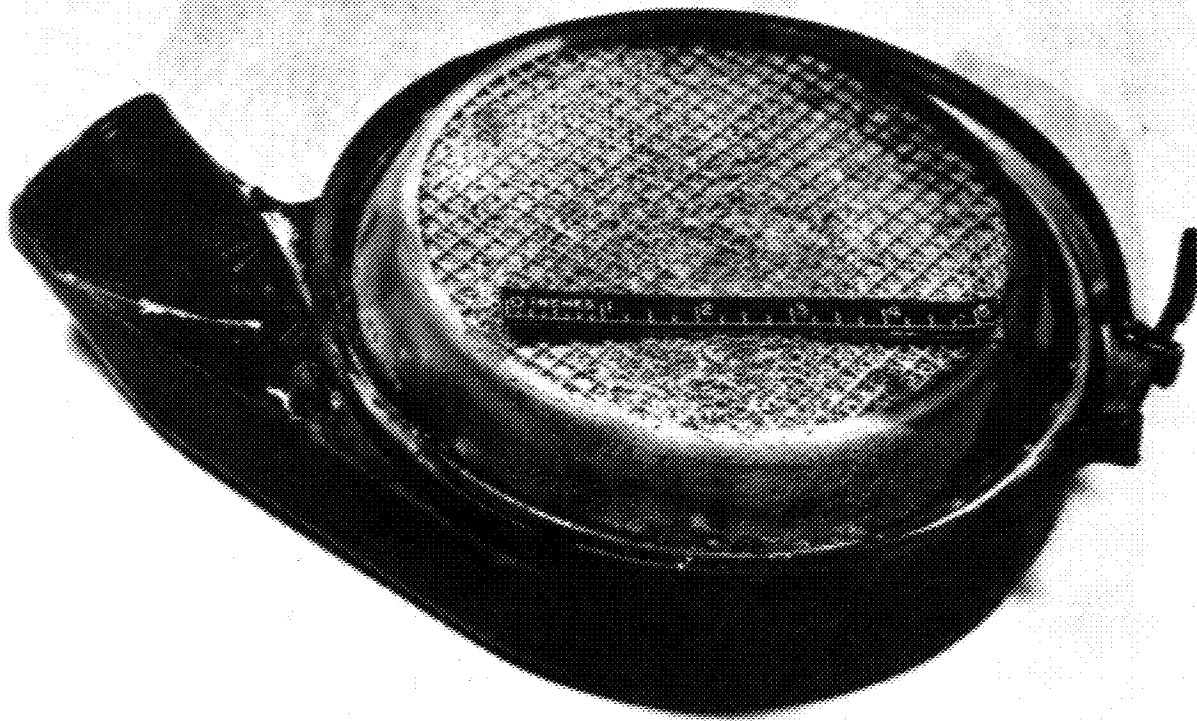
In extreme dust tests the air cleaner reached maximum restriction in 3.75 hours. During this period the air cleaner ceased to function properly and only oil wetted dust was left on the air cleaner oil cup. Pullover of oil to the engine occurred. The inside of the intake air hose connecting the carburetor to the air cleaner was covered with dust. Dust deposits were observed on all spark plug electrodes and engine cylinder compression had dropped an average of 30 psi from pretest checks.

FIGURE 4. Air cleaner upper element after extreme dust operation (02DU8370).

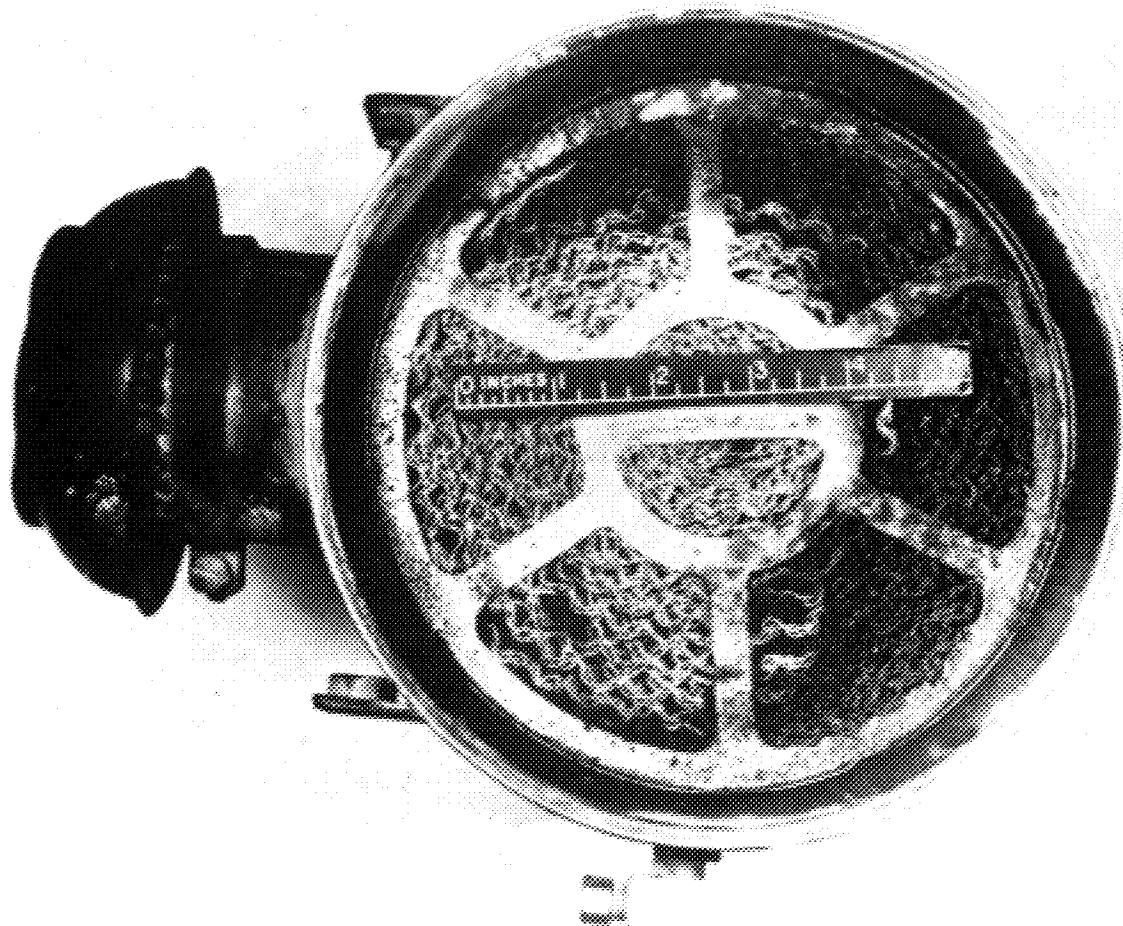
During the post-test inspection it was also observed that the inside of the distributor was covered with dust. There was no liquid oil left in the oil cup, only oil wetted dust.

FIGURE 5. Air cleaner lower element after extreme dust operation (02D08370).

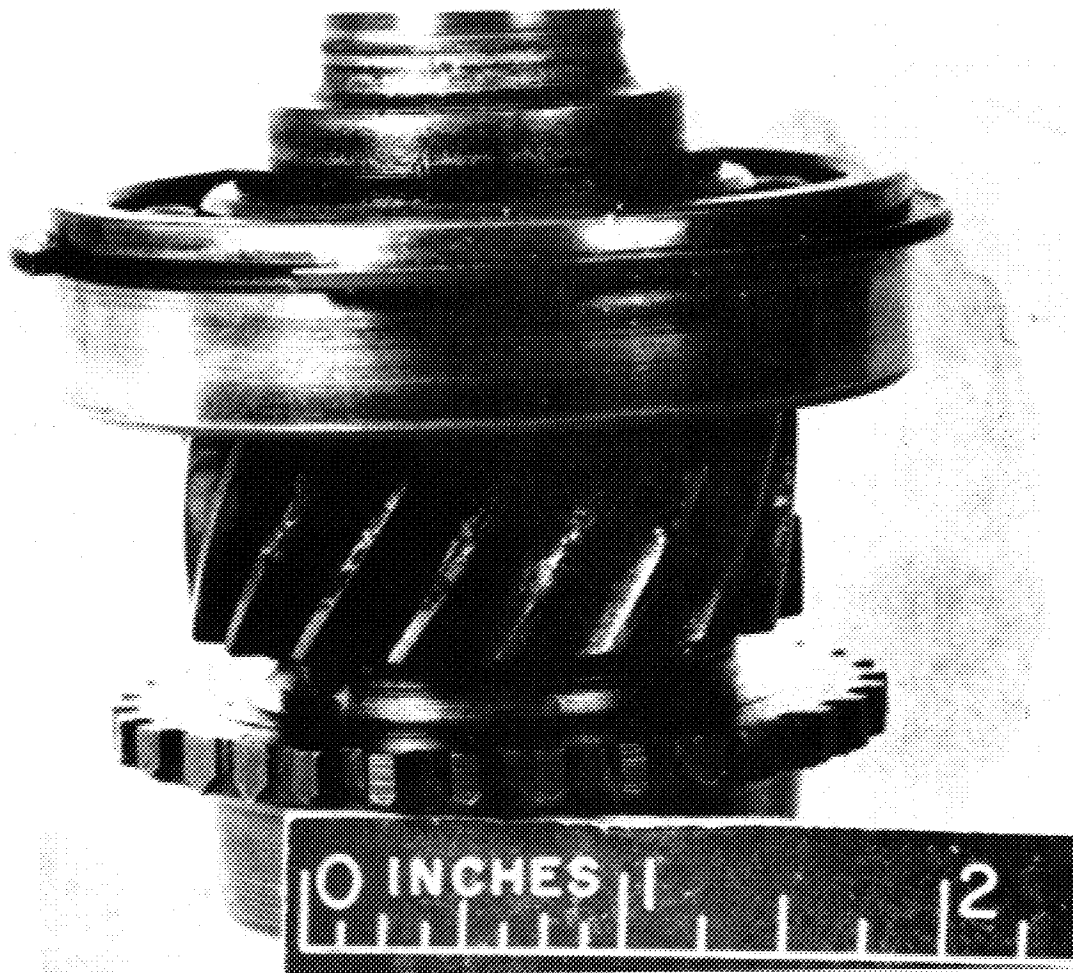
During these tests, a run was started at 1800 rpm, second gear, for which it was desired to stabilize the transmission oil sump temperature. During this test the transmission failed at a temperature of 393°. A teardown revealed that the rear output seal and the throwout bearing had failed. The transmission input gear which is on the helical spur gear shaft had many chipped teeth (Fig. 6, App I.9), the second speed helical gear was heavily surface fatigued, and the transfer input shaft helical gear had four sheared teeth (Fig. 7, App I.9). It is hypothesized that the excessive temperature damaged the rear seal, resulting in a loss of lubricant. The vehicle was running at maximum torque (1800 rpm) in second gear, and the force and minimal lubrication on the transmission input gear caused it to chip away. These chips probably jammed other gears, causing the transfer input gear teeth to shear.

FIGURE 6. Chipped teeth on transmission input shaft helical gear after transmission overheated during full load cooling runs (02DU8670).

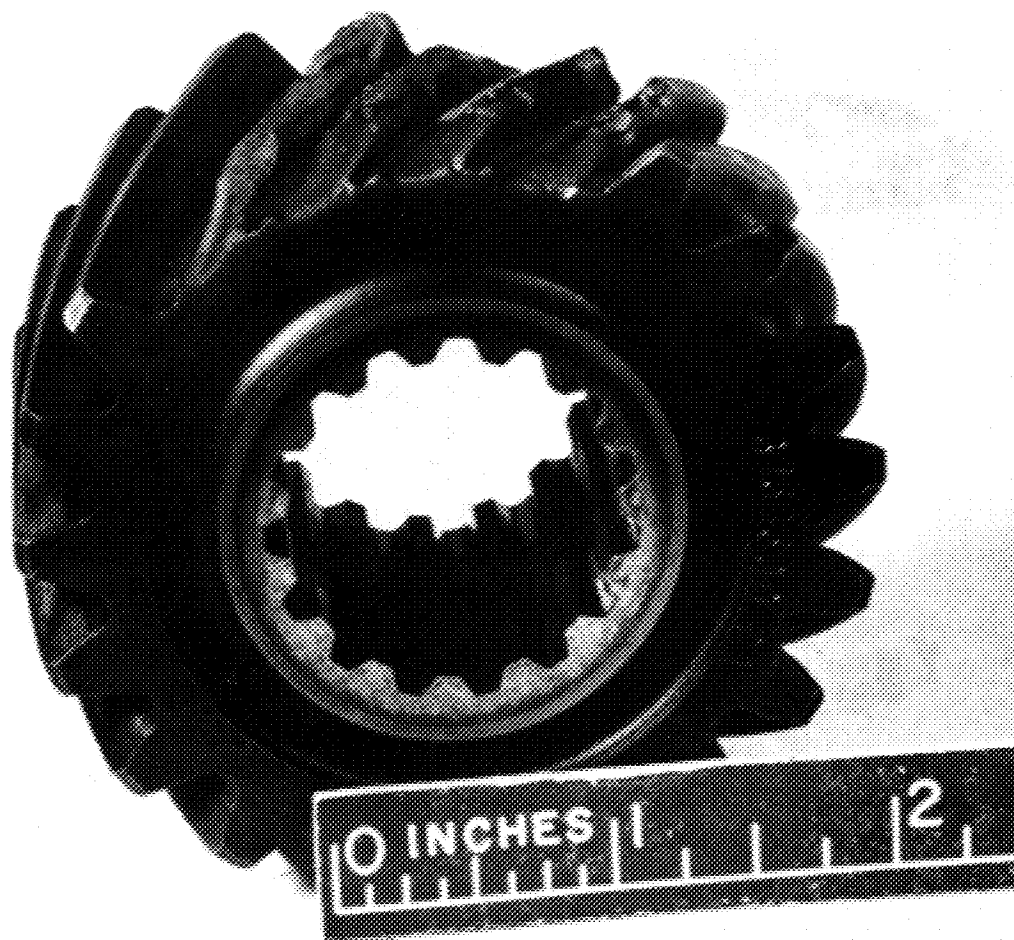
FIGURE 7. Sheared teeth on transfer input shaft helical gear after transmission overheated during full load cooling runs (02DU8670).
