Technical Report

No. 13511

M151 1/4-TON TRUCK CORROSION TEST PROGRAM (U)

NOVEMBER 1990

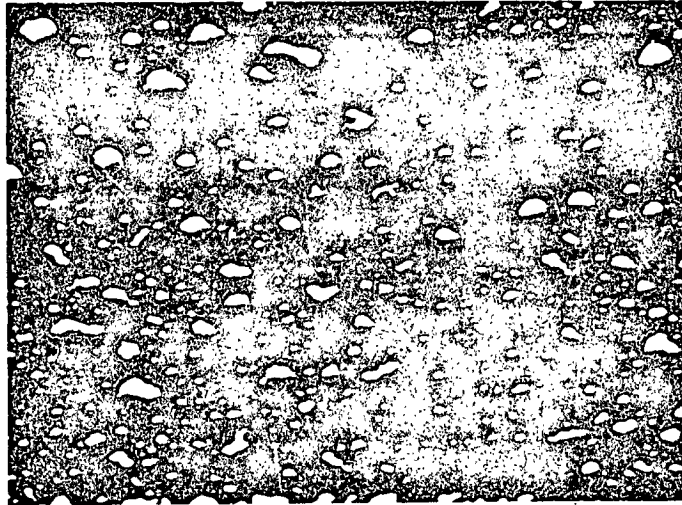
Figure D-10. Paint Blistering

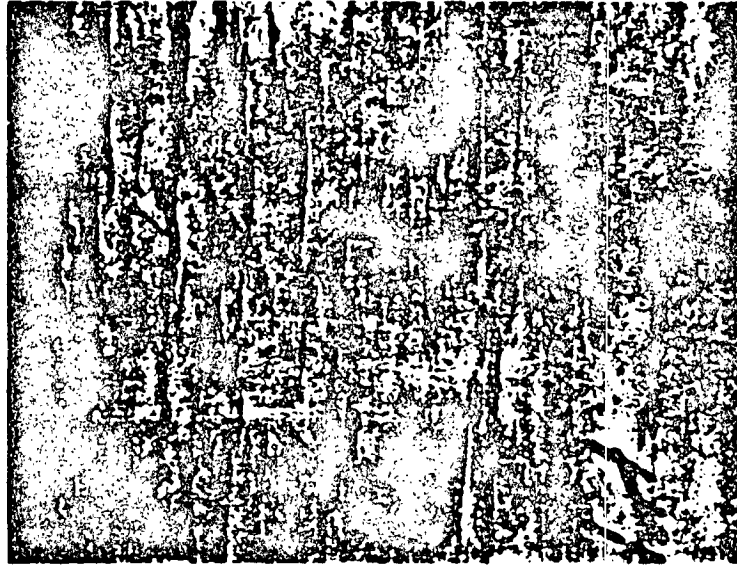
Figure D-11. Paint Peeling/Flaking

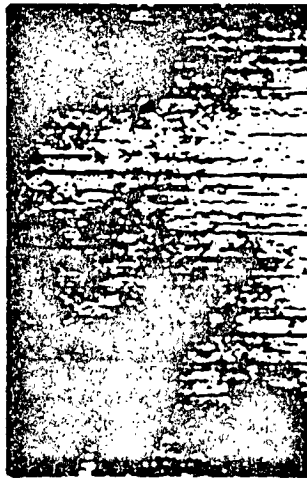
Figure D-13. Paint Cracking

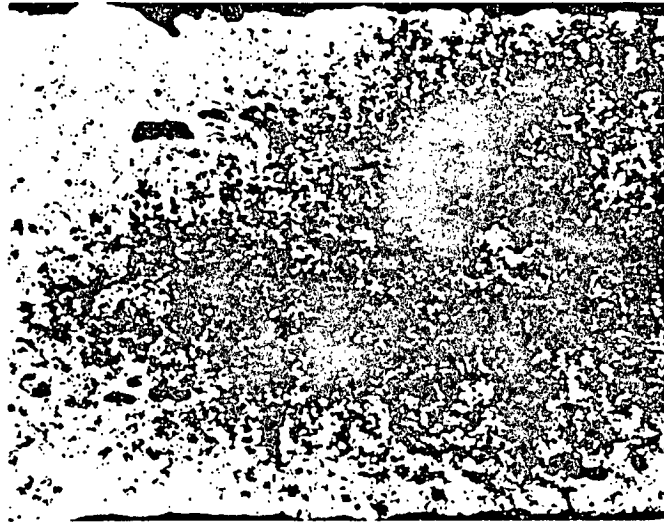
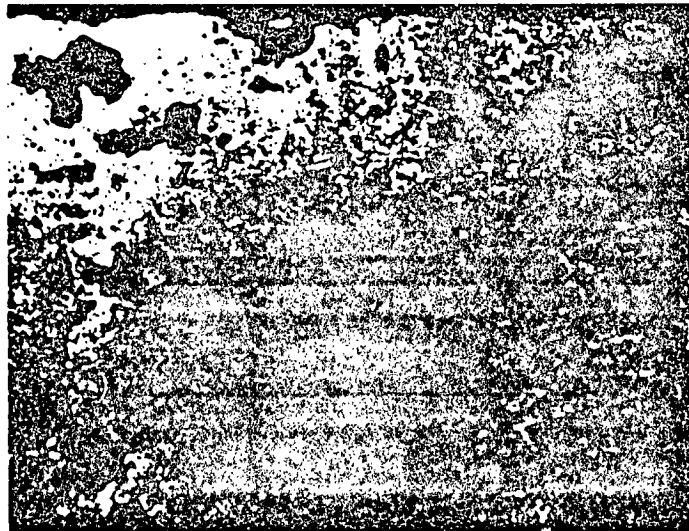
Figure D-14. Paint Chipping
