Technical Report

No. 13511

M151 1/4-TON TRUCK CORROSION TEST PROGRAM (U)

NOVEMBER 1990

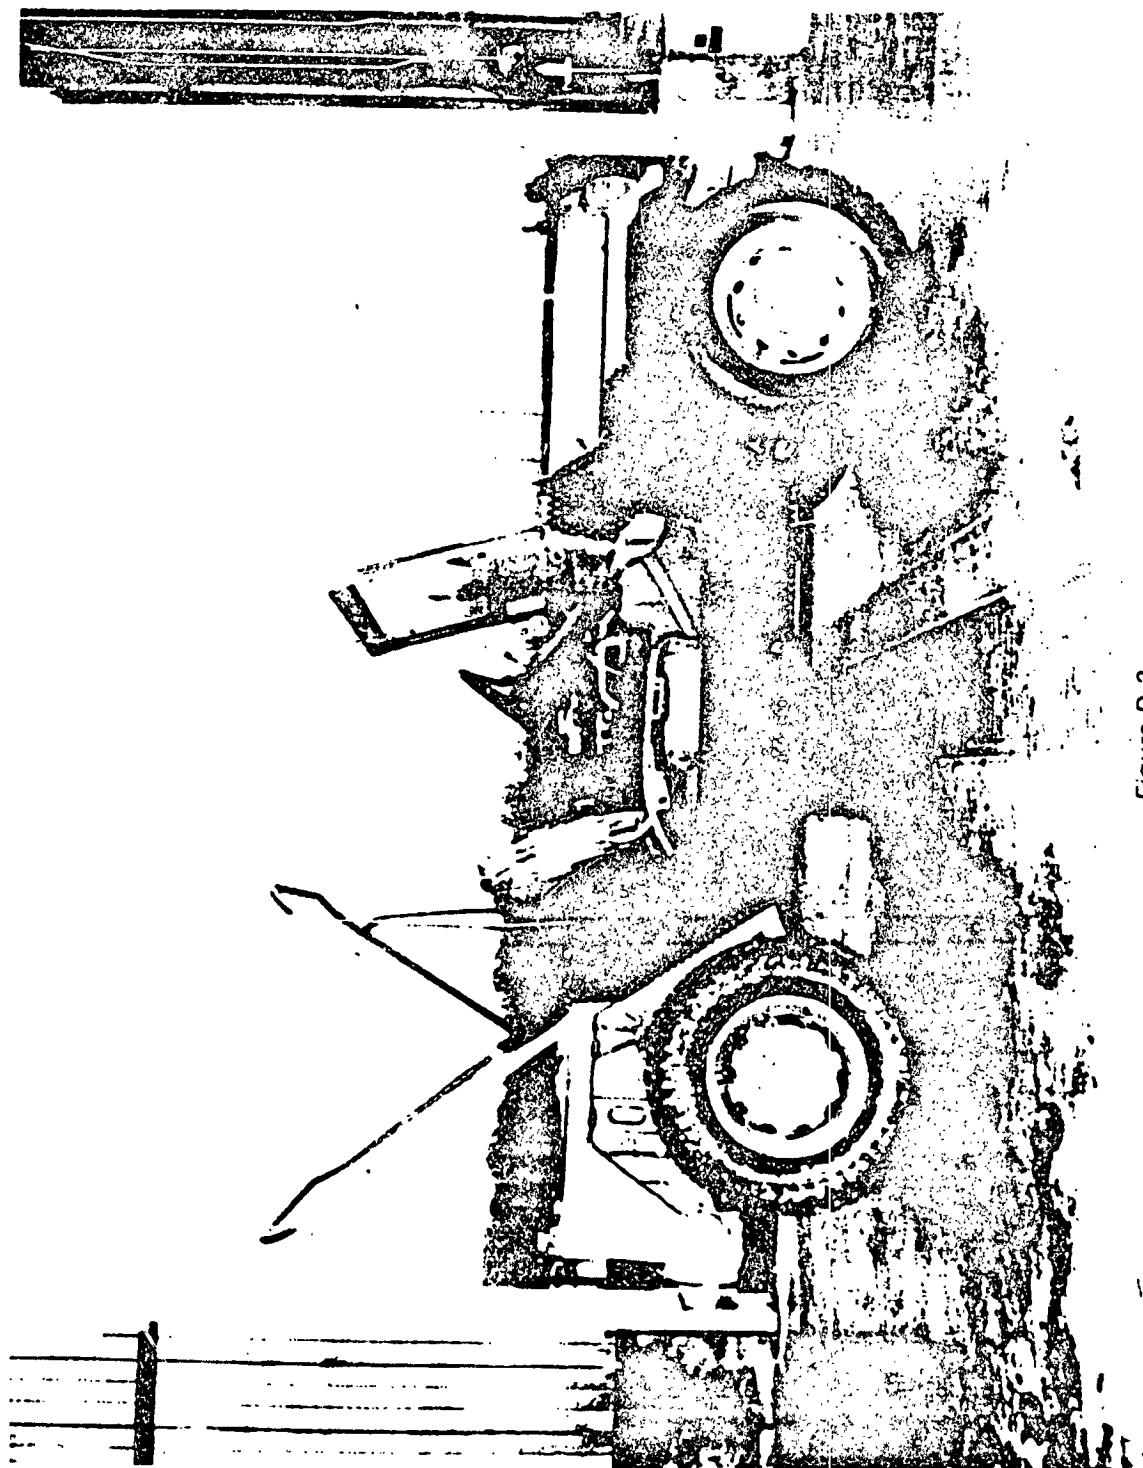
3. Right side of vehicle Figure D-3	Blistering, flaking/peeling, abrasion/erosion, cracking, chipping, paint discoloration none	None, I, II, III, IV	<input type="checkbox"/>	<input type="checkbox"/>

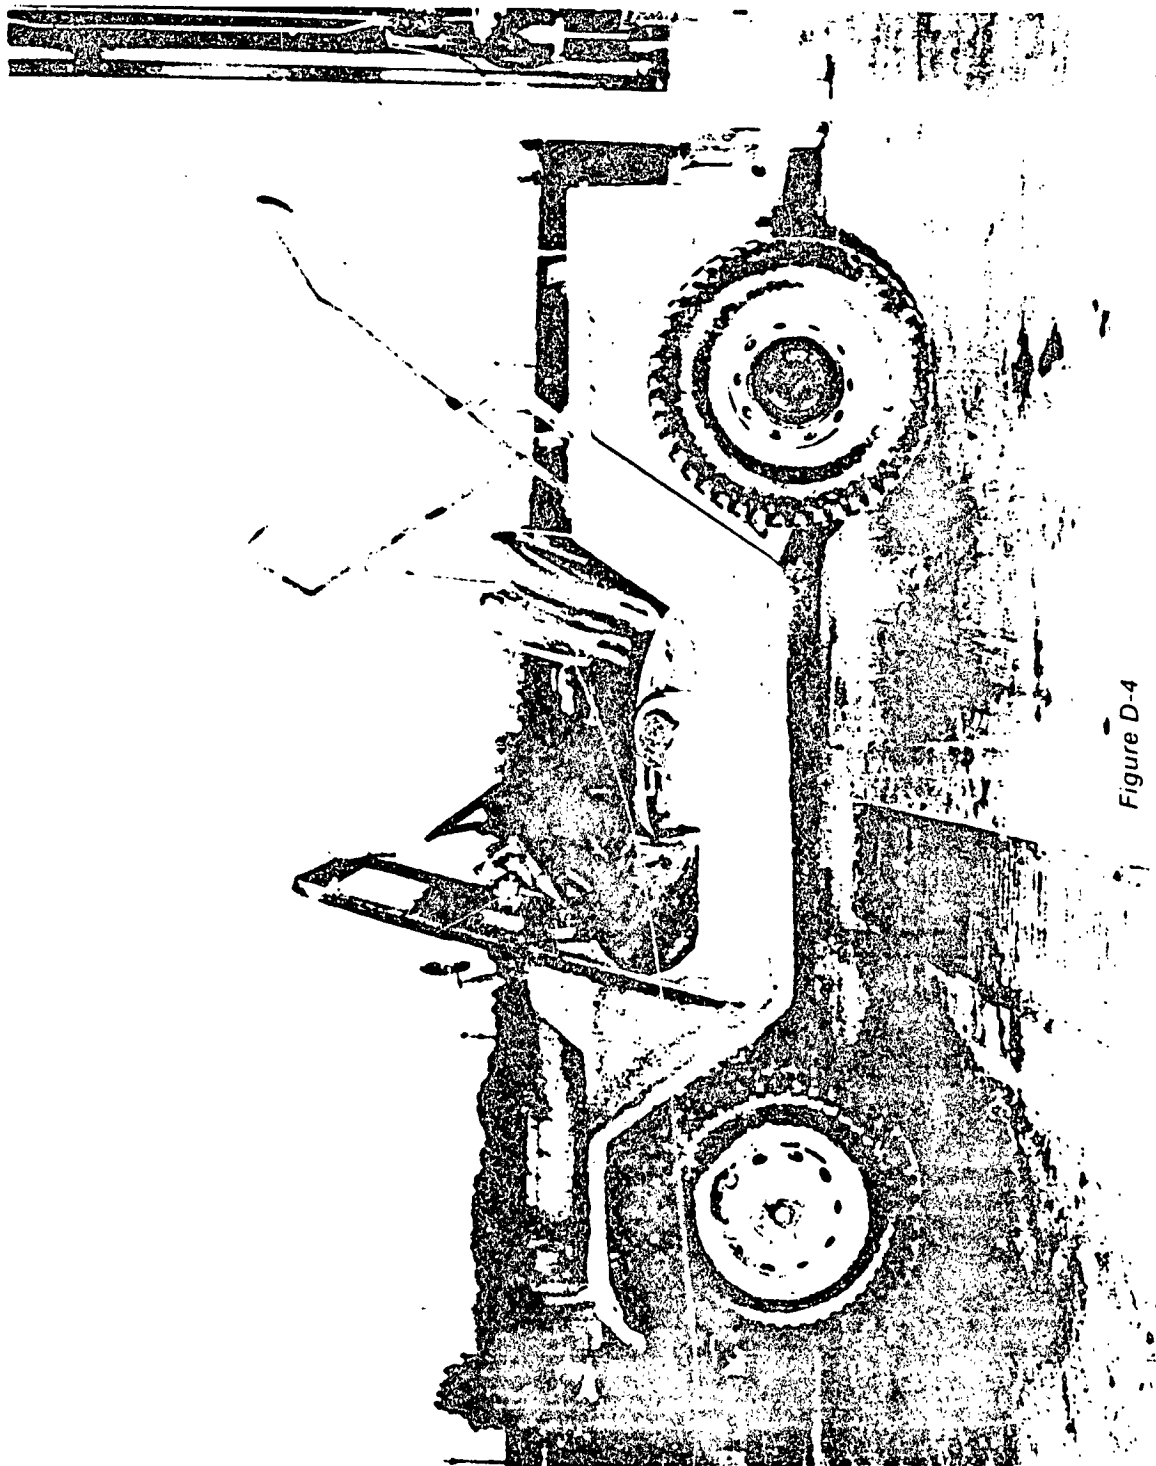
4. Left side of vehicle Figure D-4	Blistering, flaking/peeling, abrasion/erosion, cracking, chipping, paint discoloration none	None, I, II, III, IV	<input type="checkbox"/>	<input type="checkbox"/>

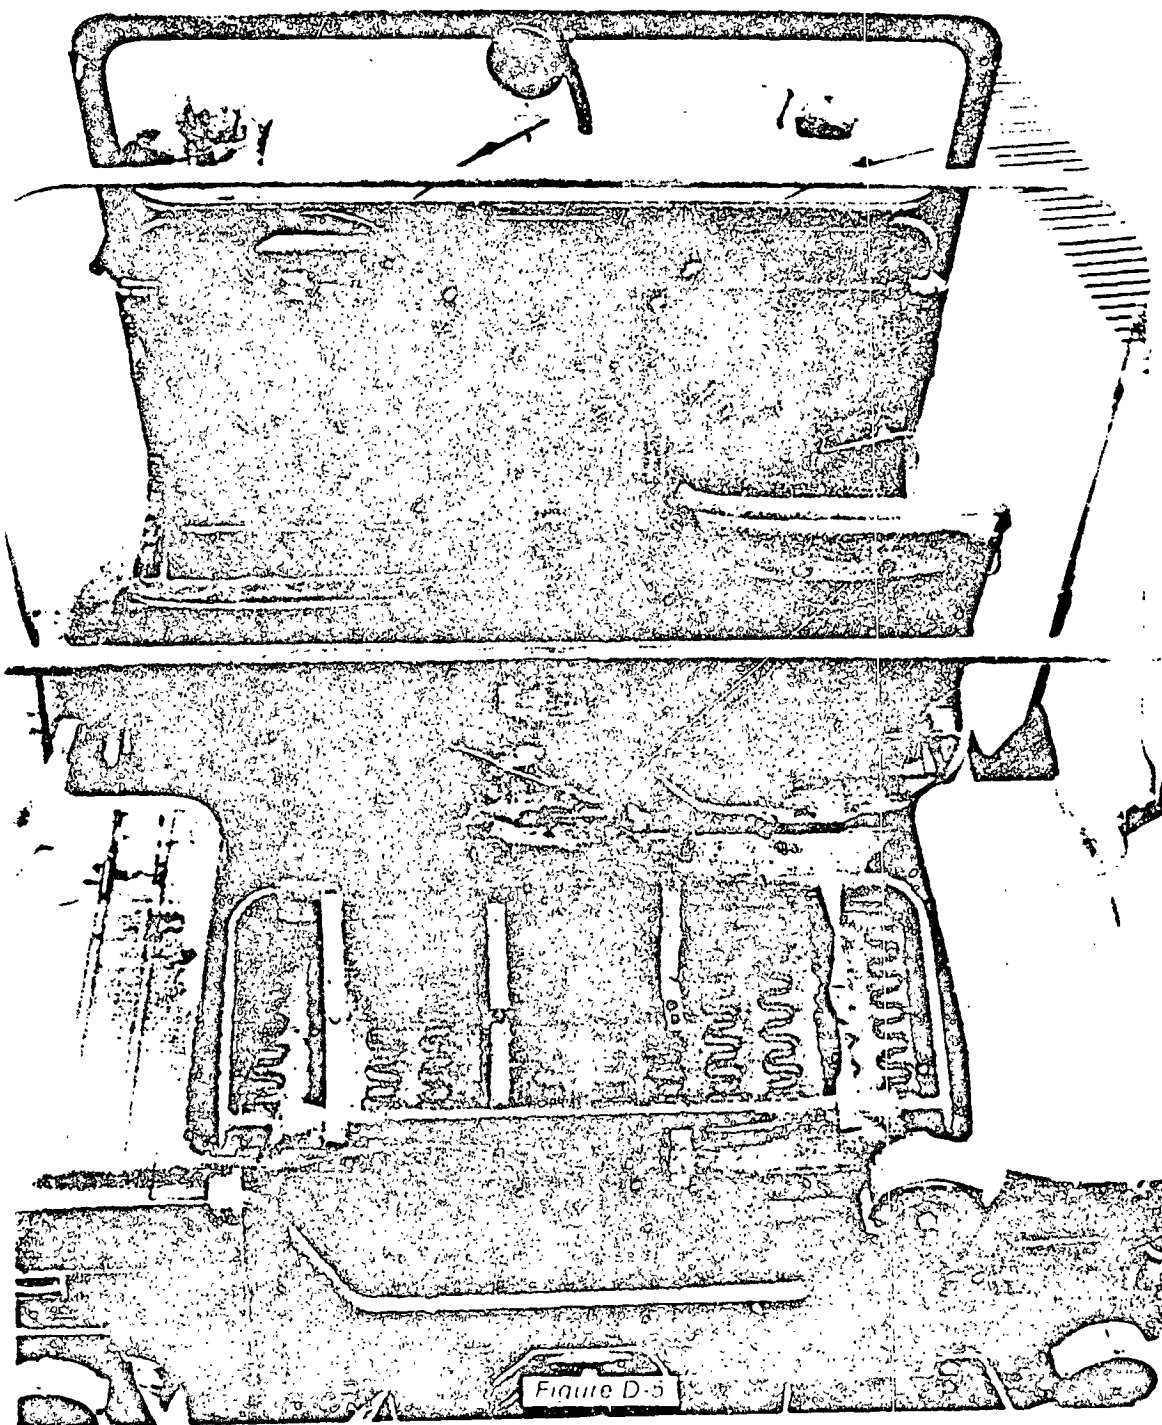
5. Passenger compartment Figure D-5	Blistering, flaking/peeling, abrasion/erosion, cracking, chipping, paint discoloration none	None, I, II, III, IV	<input checked="" type="checkbox"/>	<input type="checkbox"/>

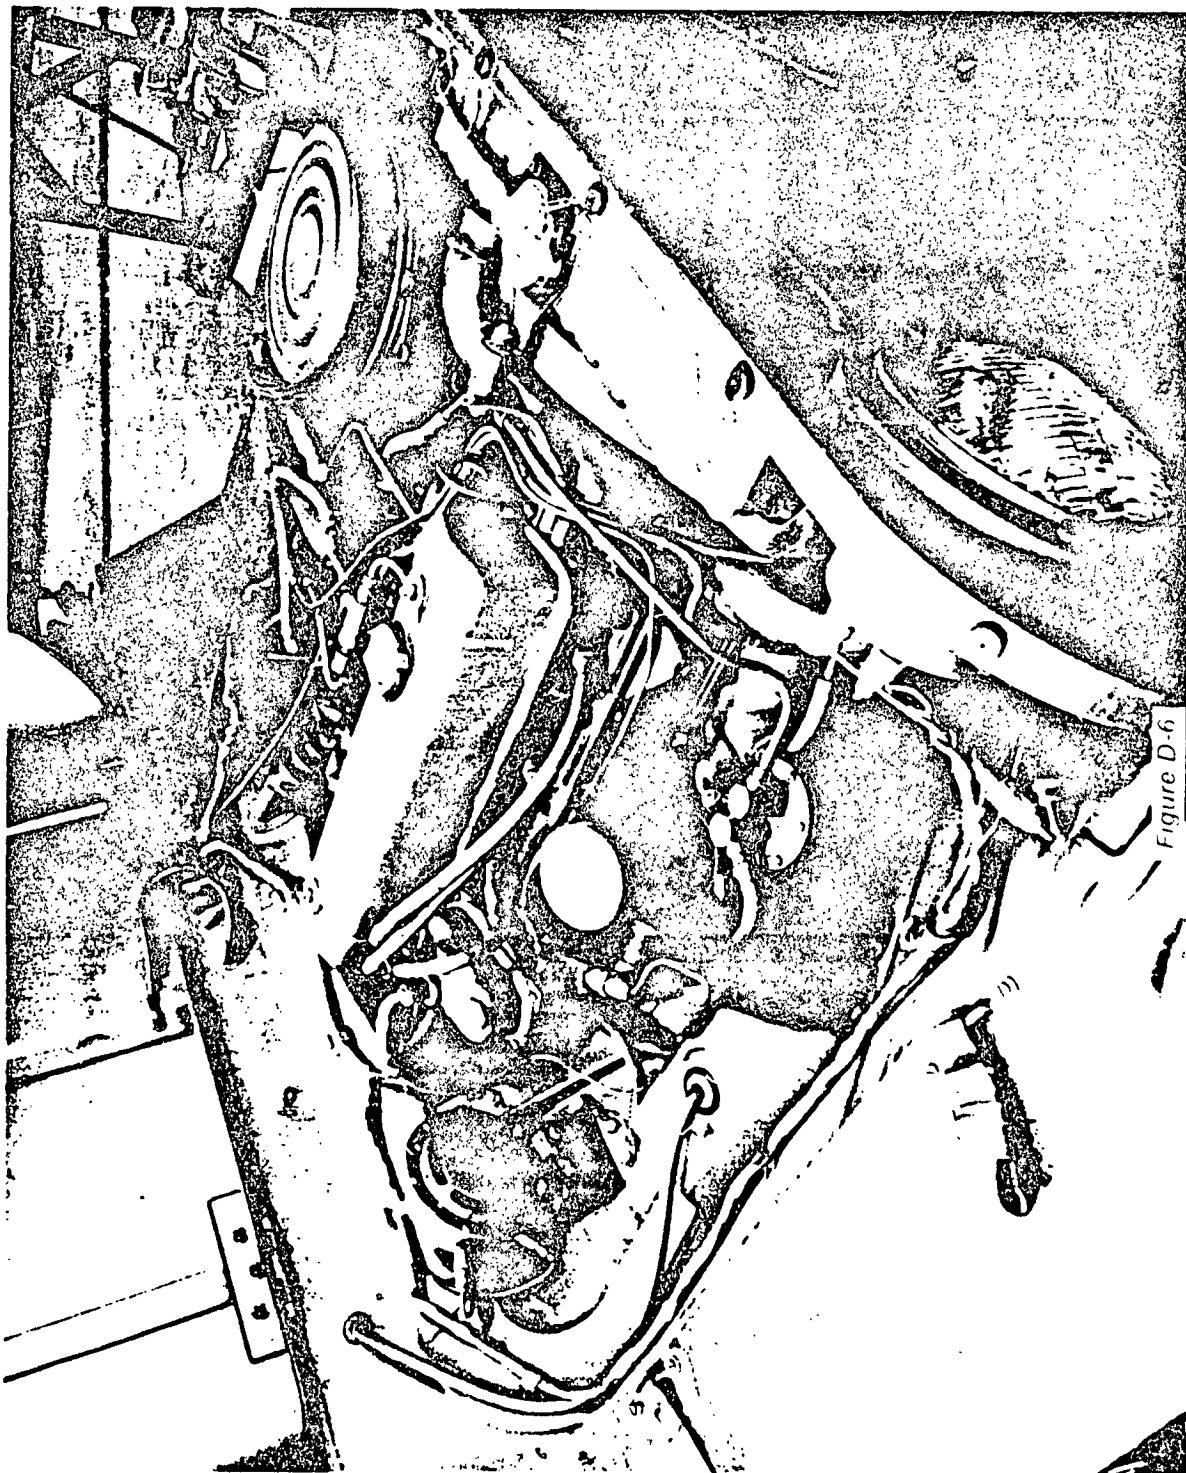
6. Engine compartment Figure D-6	Blistering, flaking/peeling, abrasion/erosion, cracking, chipping, paint discoloration none	None, I, II, III, IV	<input type="checkbox"/>	<input type="checkbox"/>

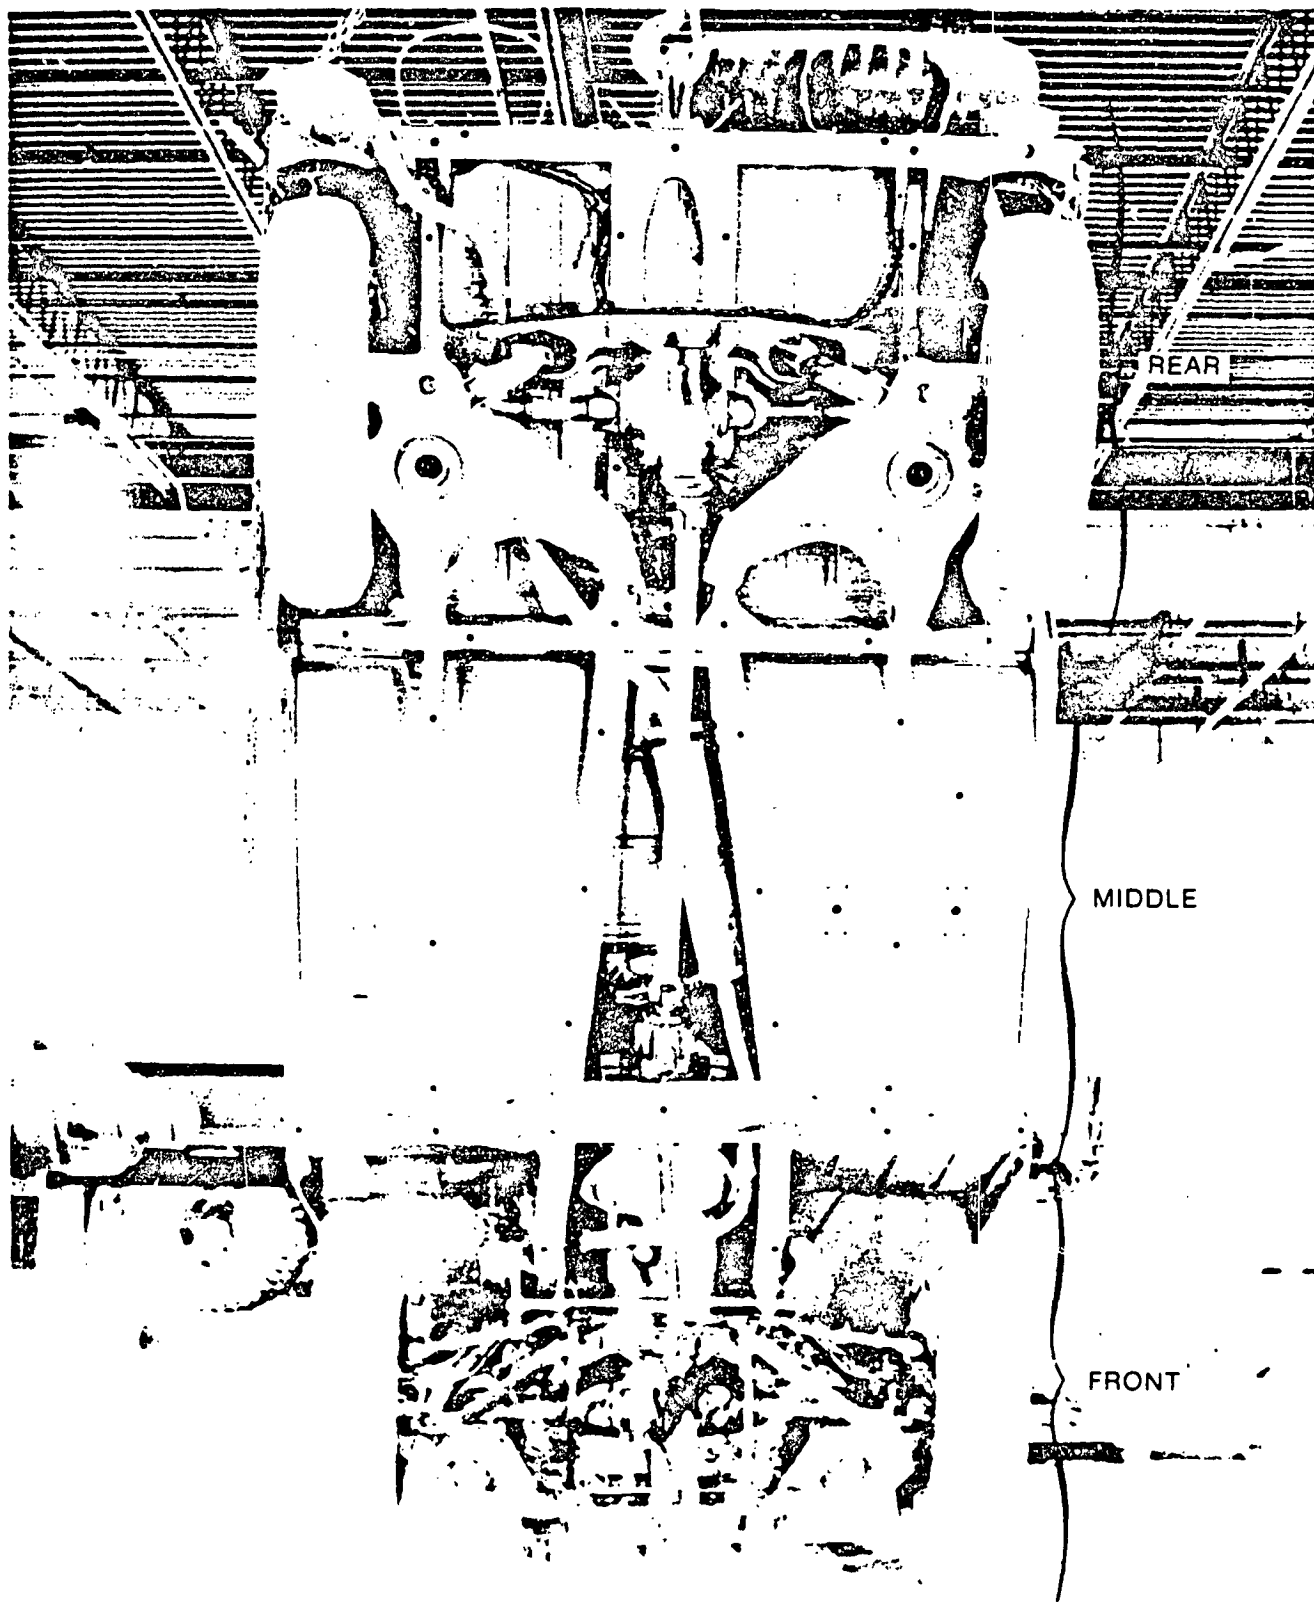
7. Underbody front Figure D-7	Blistering, flaking/peeling, abrasion/erosion, cracking, chipping, paint discoloration none	None, I, II, III, IV	<input type="checkbox"/>	<input type="checkbox"/>

8. Underbody middle Figure D-7	Blistering, flaking/peeling, abrasion/erosion, cracking, chipping, paint discoloration none	None, I, II, III, IV	<input checked="" type="checkbox"/>	<input type="checkbox"/>

9. Underbody rear Figure D-7	Blistering, flaking/peeling, abrasion/erosion, cracking, chipping, paint discoloration none	None, I, II, III, IV	<input type="checkbox"/>	<input type="checkbox"/>
